BOULEVARD TREE FAILURES
DURING WIND-LOADING EVENTS:
JUNE 21, 2013...A CASE STUDY

A REPORT TO THE MINNEAPOLIS CITY
COUNCIL FEBRUARY 3, 2015

UNIVERSITY OF MINNESOTA
DEPARTMENT OF FOREST
RESOURCES

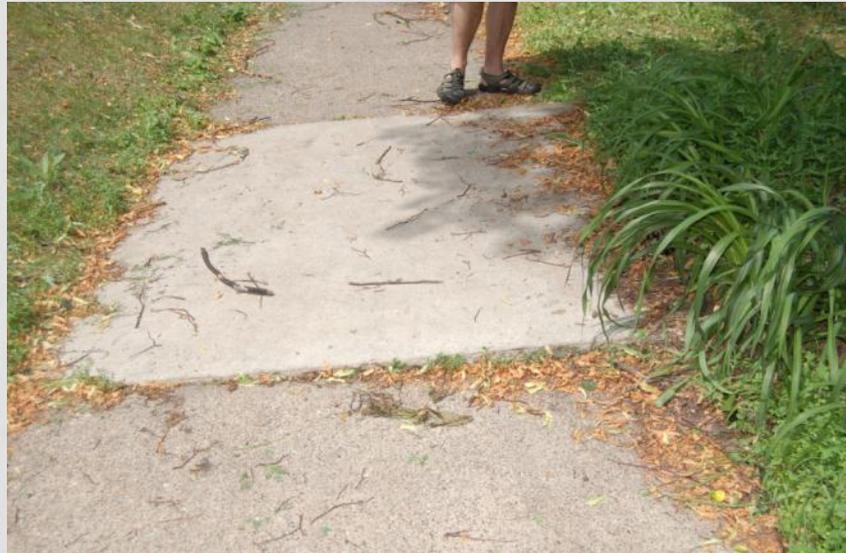
RESULTS: SIDEWALK REPLACEMENT

- The major finding is that **having replacement work done increased the odds of root failure by 2.24 times** (95% CI: 1.77, 2.83; $p < 0.0001$).
- For illustration, when no replacement work was done, the average Tilia had a 10.6% chance of root failure; this increased to 21.0% when replacement work was done.

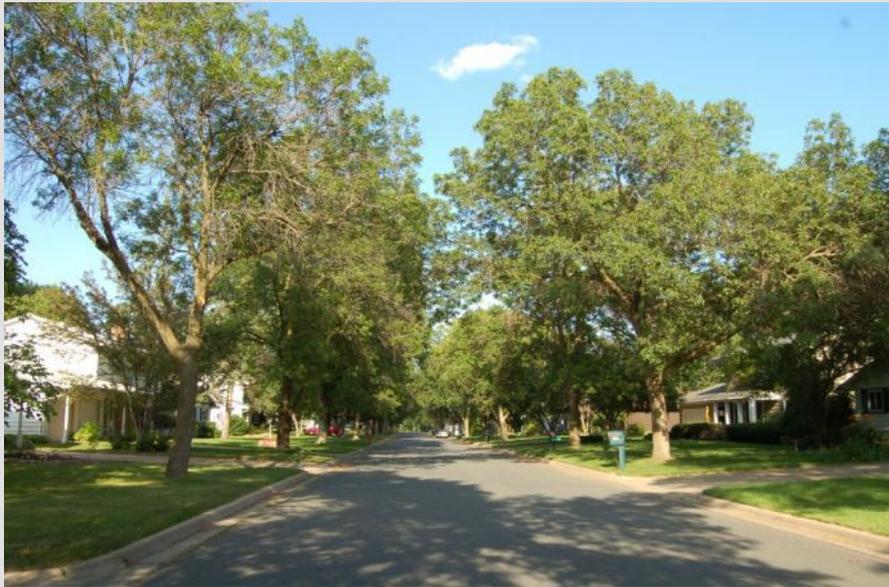
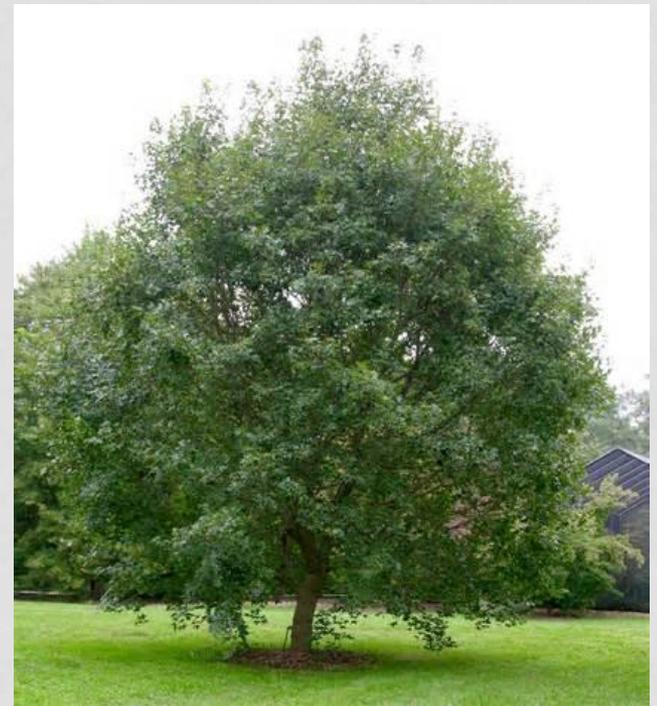
RESULTS: SPECIES

*Tree species, when combined with replacement work, was also significant, with Tilia most likely to fail, followed by Fraxinus (ash), Acer (maple) and Ulmus (elm) in order. Essentially, **when sidewalk replacement work was done near any one of these trees, the rate of failures more than doubled (p=.0001)***

1. **Littleleaf Linden Most Likely to Fail**
2. **Green Ash**
3. **Maples**
4. **Elms**
5. **Others**

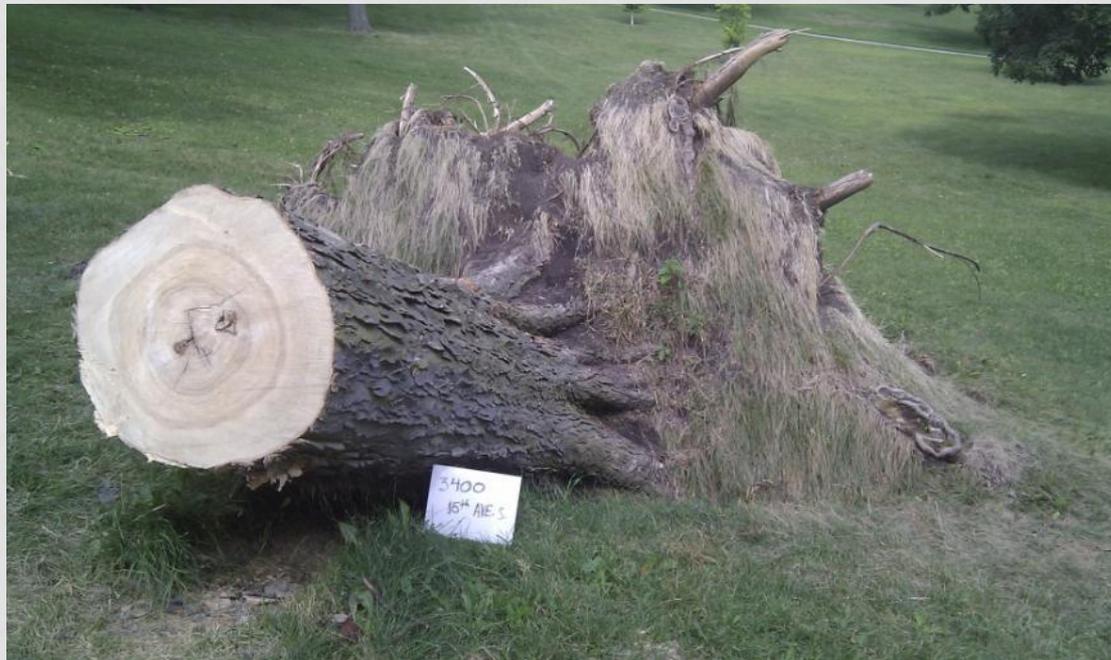
RESULTS: D.B.H.

*Tree size, measured as trunk diameter (DBH), was significantly related to failure rates, with **larger tree diameters more likely to fail (p=.008) independent of whether sidewalk replacement work was conducted.***

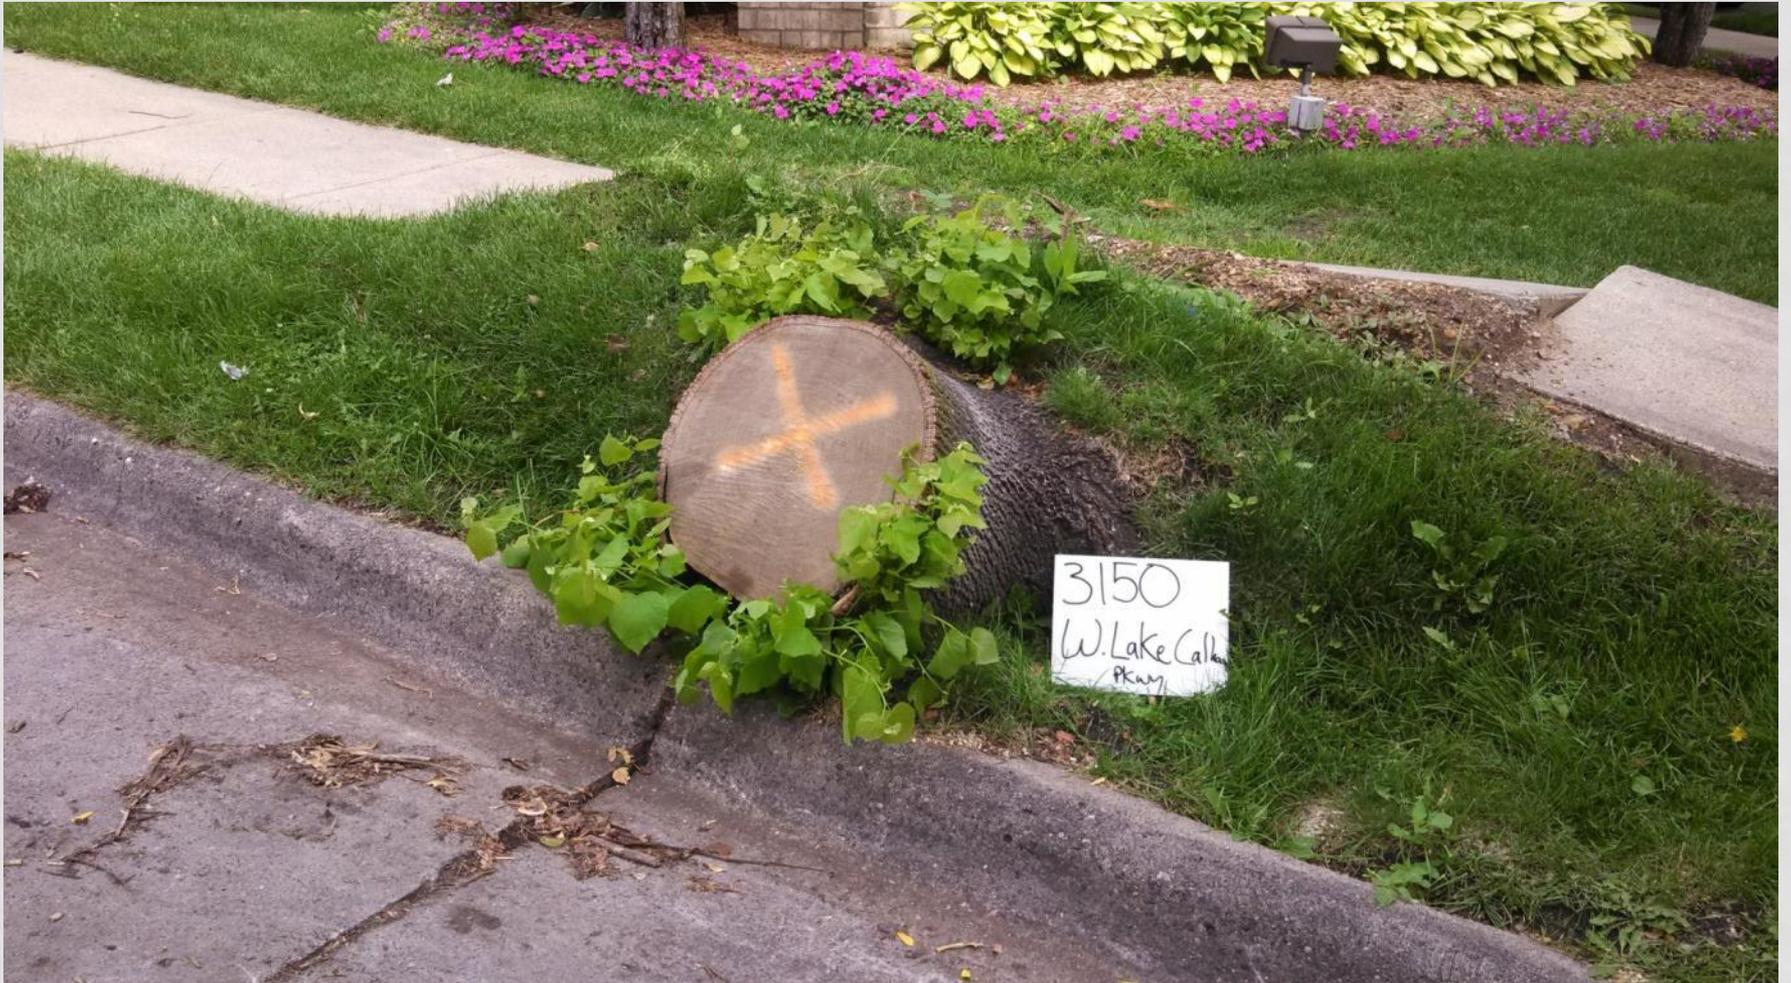
RESULTS: BOULEVARD WIDTH

Boulevard width was significantly related to tree failures ($p=.011$) only when sidewalk replacement work was conducted. For example, a *Tilia* in a boulevard four (4) feet wide that had experienced sidewalk replacement damage to its root system had a failure rate of 29.4%. The same tree in an eight (8) foot wide boulevard had a failure rate of 14.6%.

1. Cutting Roots Jeopardizes Stability.
2. Consult with Foresters/Horticulturists/Arborists.
3. Wider is Better...for Boulevards.
4. Larger Trees Need Larger Boulevards.
