# 4140 – 4146 Fremont Avenue North Minneapolis, MN

## Structural Condition Assessment

February 6, 2016

Re: 4140 – 4146 Fremont Avenue North - Structural Condition Assessment  
CDG Project 16010.00

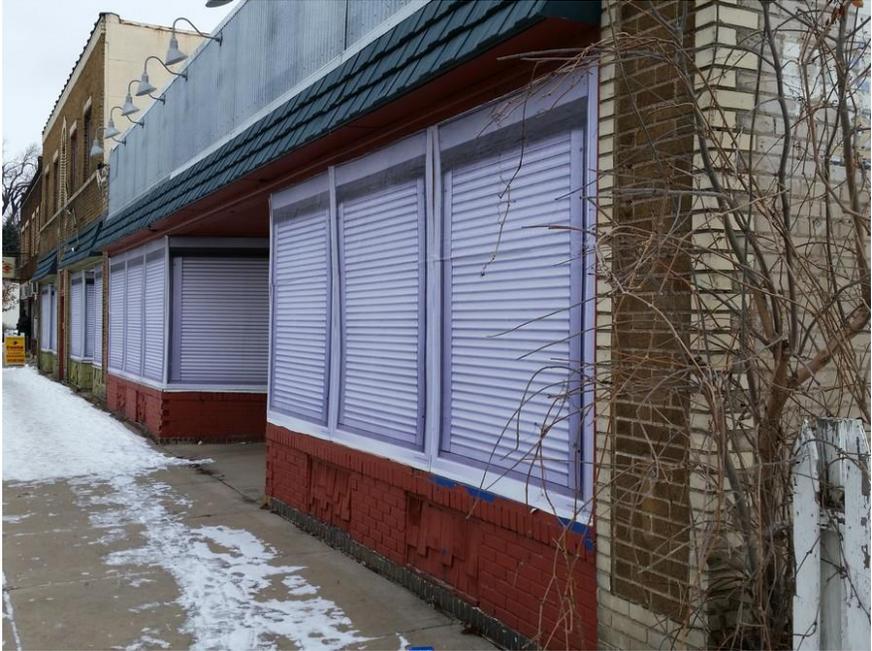
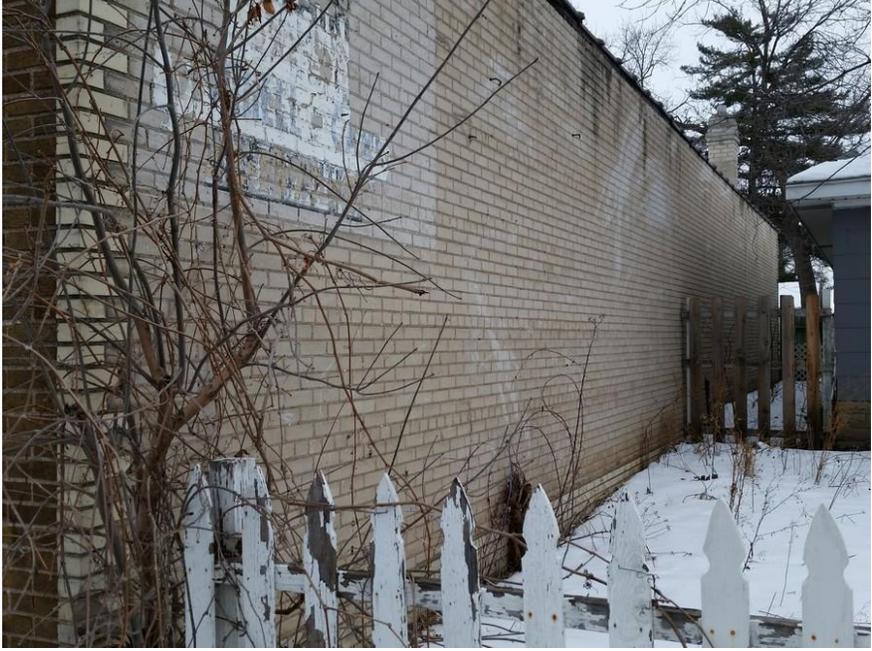
| OBSERVATIONS | REFERENCE PHOTO |
|--|--|
| <p><b>4140 Fremont Ave.</b></p> <ol style="list-style-type: none"><li data-bbox="251 420 527 682">1. The building is a one story retail building with the west side fronting on Fremont Avenue. 4140 is the south portion of this building.</li><li data-bbox="251 1102 535 1459">2. The south side of this building is constructed with brick masonry, and appears to be in overall good structural condition, with some areas of minor cracking and deterioration.</li></ol> | |

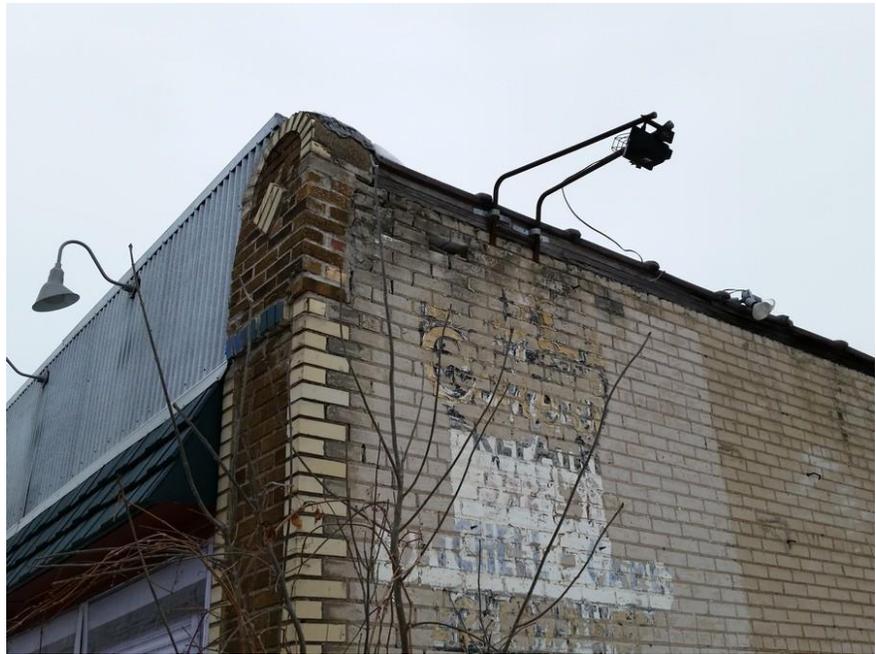
- 3. Some deterioration of the brick masonry is evident, likely due to water infiltration.

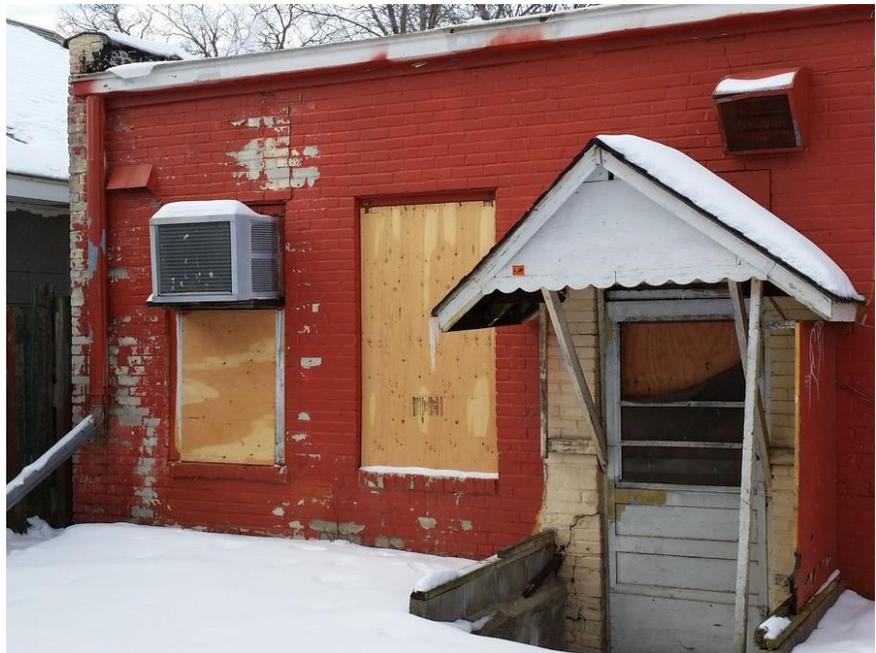
- 4. The east side of the building is constructed with painted brick masonry. Some deterioration of the brick masonry is evident, likely due to moisture being trapped in the masonry by the paint.

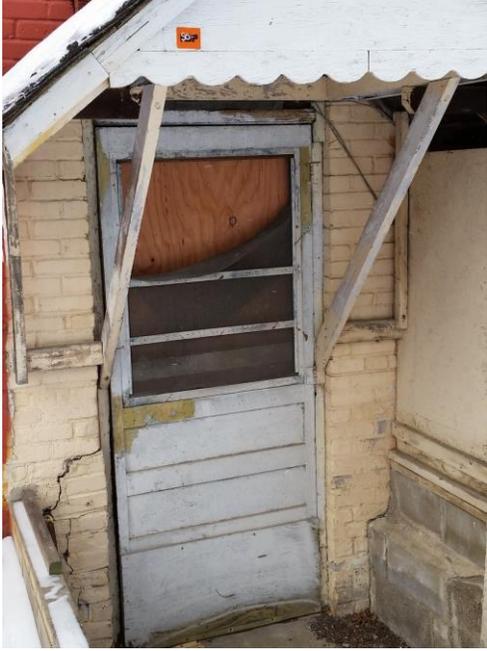
| OBSERVATIONS | REFERENCE PHOTO |
|---|--|
| 5. Some cracking of the brick masonry is evident. | |

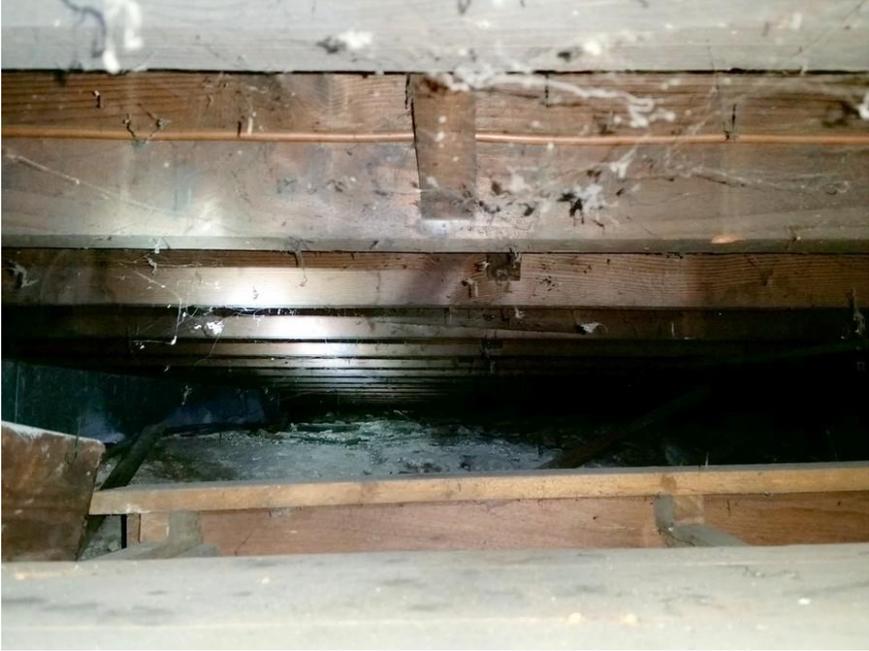
| OBSERVATIONS | REFERENCE PHOTO |
|---|--|
| 6. A crawlspace is located under the west half of the first floor. The floor is framed with wood joists, supported by masonry walls. The framing was mostly inaccessible for inspection, but appears to be in overall good condition. | |

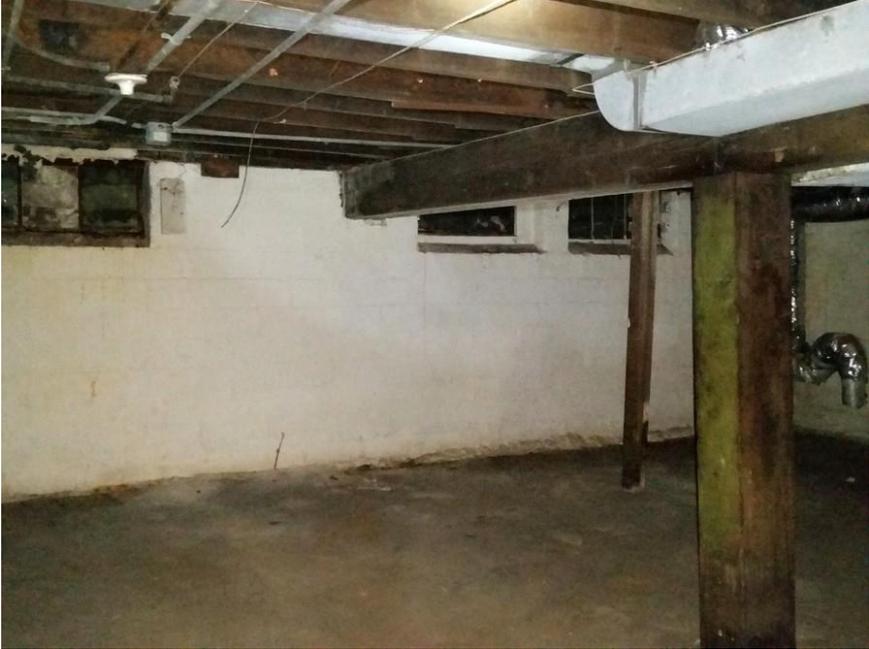
| OBSERVATIONS | REFERENCE PHOTO |
|---|---|
| <p>7. A basement is located under the east half of the first floor. The floor is framed with wood plank sheathing supported by wood joists, beams, and columns. All framing appears to be in overall good condition, with some localized deterioration.</p> | A photograph of a basement interior. The ceiling consists of dark wood joists and beams. A large, light-colored concrete pipe runs horizontally across the upper right. The walls are white and appear somewhat aged. The floor is a smooth, light-colored concrete. A vertical wooden post supports the ceiling structure. |

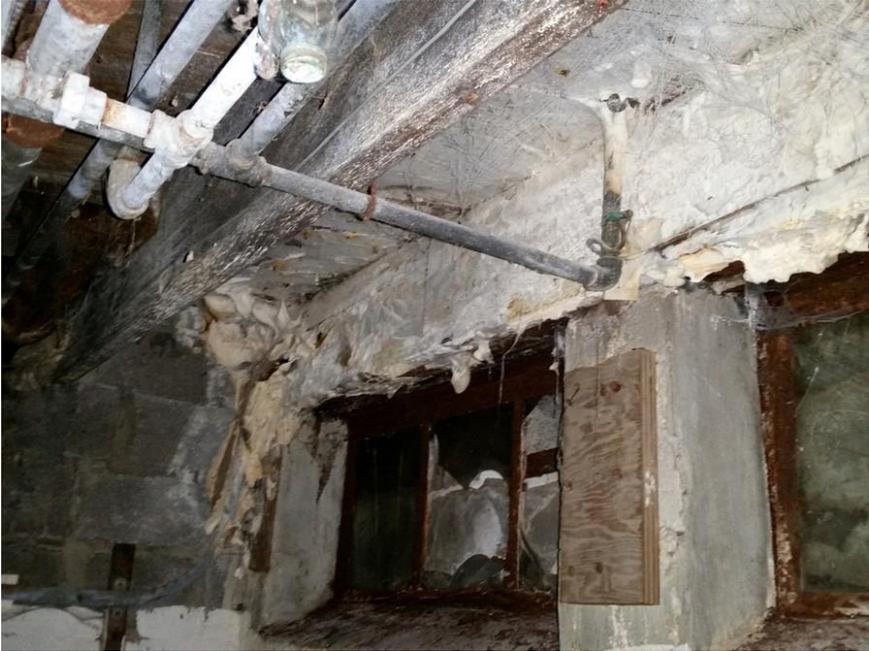
| OBSERVATIONS | REFERENCE PHOTO |
|---|---|
| <p>8. Heavy biological growth is evident on the floor framing on the east side of the basement.</p> | A close-up photograph of the basement's structural elements. It shows a network of pipes and wooden framing. There is a significant amount of white, fuzzy biological growth (mold or mildew) covering the surfaces, particularly on the pipes and the wood. The lighting is dim, highlighting the texture of the growth. |

The deterioration of the wood framing identified in the observations above is all due to excessive moisture or water infiltration. Significant biological growth discovered in 4140 and 4142 Fremont on the underside of the first level floor structure on the east side of the basement is an indication that there is excessive moisture in the wood framing members. The deterioration of the wood floor sheathing, joists, and beams is also the result of water infiltration along the east side of the building. This water infiltration must be corrected prior to the repair or replacement of the deficient wood framing identified above. Although the investigation and recommendations for the correction of the water infiltration is outside of the scope of this report, it is typically the result of poor site drainage.

- Deteriorated first level floor joists on the east side of the basement: All wood joists with biological growth and decay should be removed and replaced. This will likely include the replacement of some of the wood floor sheathing as well.
- Deteriorated wood column bases: The bottoms of all of the wood columns should be cut off and new concrete or steel column bases installed.
- Corroded steel lintels over window openings: Replace the lintels with new galvanized steel angles to match existing. The brick masonry above will likely need some repair as part of this replacement.

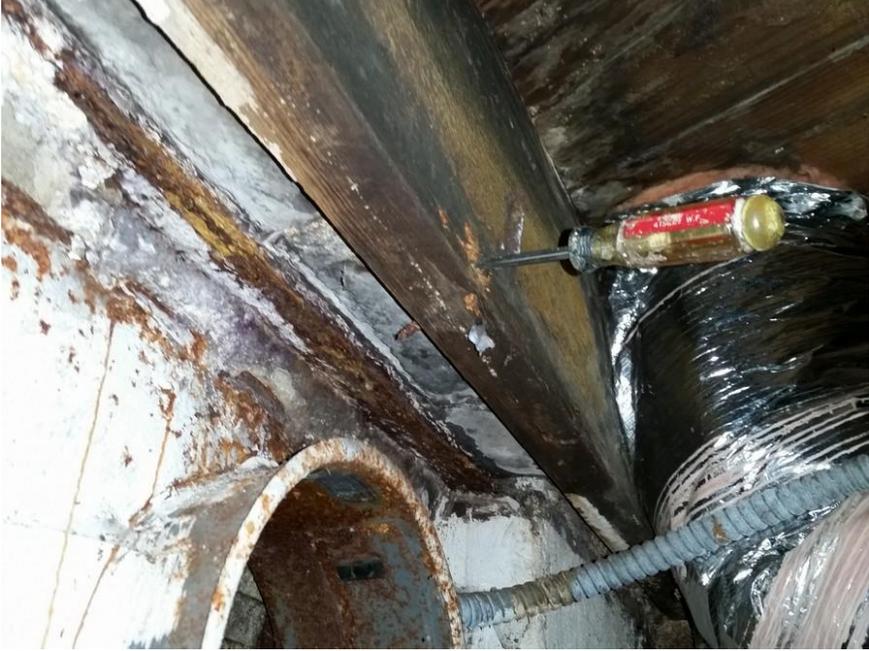
| OBSERVATIONS | REFERENCE PHOTO |
|---|---|
| 9. The first two joists on the underside of the east side of the first level are in poor condition, with significant deterioration. | A close-up photograph of a wooden joist in a basement. The wood is heavily weathered and shows signs of significant deterioration. A red-handled screwdriver is placed against the joist for scale. Below the joist, there is a rusted metal pipe or fitting. The surrounding area is cluttered with various pipes and electrical conduits. |

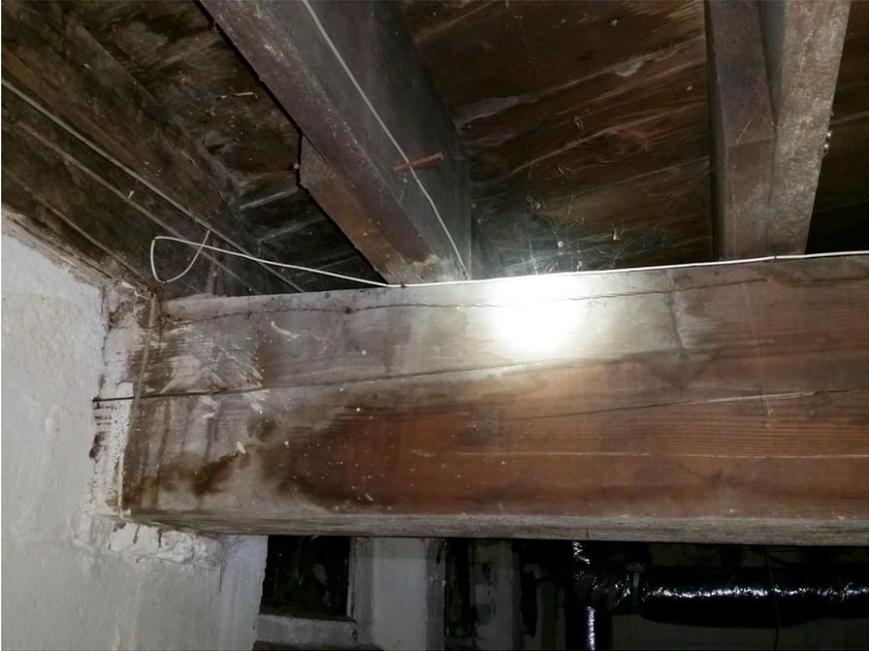
| OBSERVATIONS | REFERENCE PHOTO |
|---|---|
| 10. The wood beam is supported on the masonry wall at the east side of the basement. | A photograph showing a large wooden beam supported on a masonry wall. The beam is positioned horizontally and is supported by a vertical masonry wall on the left side. The wood shows some staining and wear. The background shows other structural elements of the basement, including other beams and pipes. |

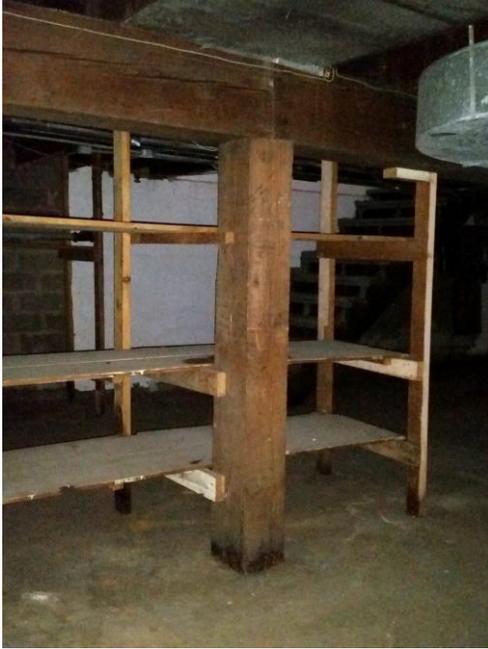
| OBSERVATIONS | REFERENCE PHOTO |
|---|--|
| <p>11. The wood beams are supported at the interior of the basement with wood columns, that are in turn bearing directly on concrete foundations.</p> | A photograph of a basement interior showing a network of wooden beams. A central, thick wooden column supports the beams. The floor is concrete, and there are some pipes and ductwork visible in the background. |

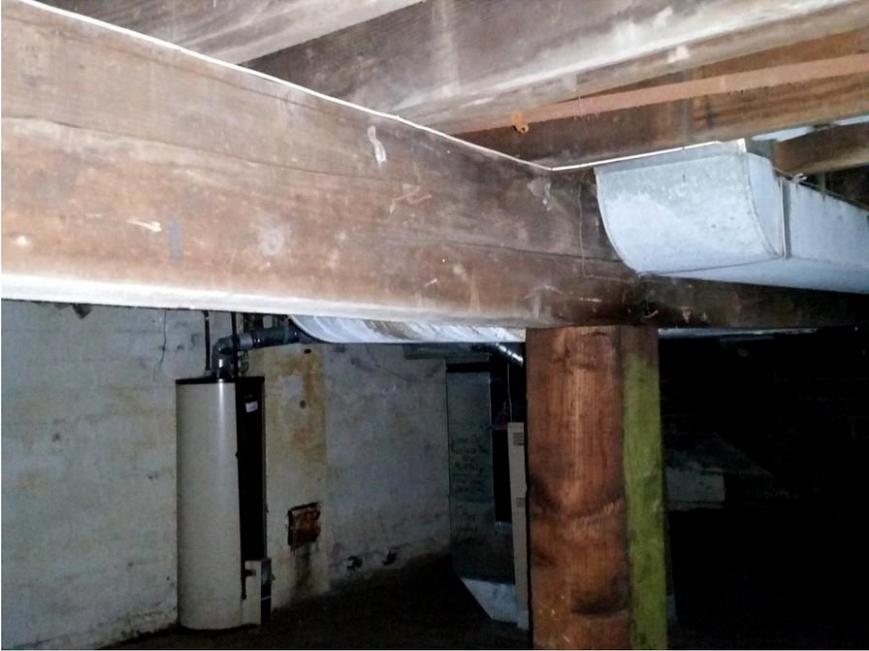
| OBSERVATIONS | REFERENCE PHOTO |
|---|--|
| <p>12. The first column from the east appears to be lower than the others. This condition is creating a noticeable slope on the first level.</p> | A close-up photograph of a wooden column supporting a wooden beam. The ceiling structure above the beam shows a noticeable slope, indicating a structural issue. There are some pipes and ductwork visible in the background. |

The apparent sagging floor on the first level of 4140 Fremont is not caused by settling foundations, but rather from the deterioration of the base of the wood column. The columns are deteriorating due to moisture being wicked up from the damp concrete floor and foundations. This can be corrected by installing column bases such as what has been installed under the columns on the north half of the basement at 4146 Fremont. Although they are not currently structurally deficient, the columns at 4142 Fremont and the south half of 4146 Fremont would also benefit from the installation of bases under the columns to prevent future deterioration.

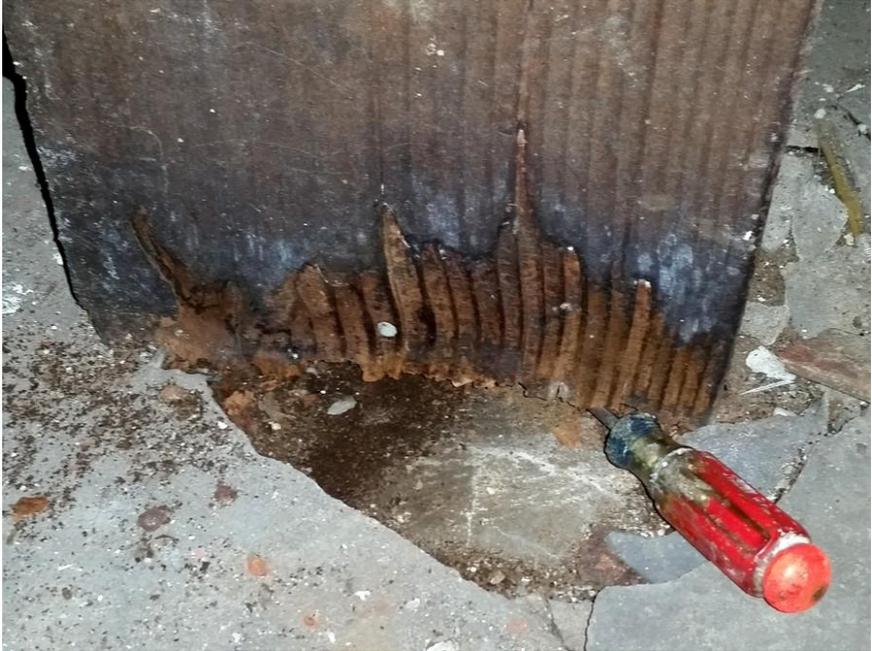
| OBSERVATIONS | REFERENCE PHOTO |
|---|--|
| <p>13. The bases of the wood columns are rotting, and are in poor condition.</p> <p>Also note that the concrete slab appears to be just a thin topping over the original slab or footing.</p> | A close-up photograph showing the base of a wood column where it meets a concrete slab. The wood is heavily rotted and discolored. A red-handled screwdriver is placed on the concrete surface next to the column base to provide a sense of scale. The concrete appears to be a thin topping over a larger footing. |

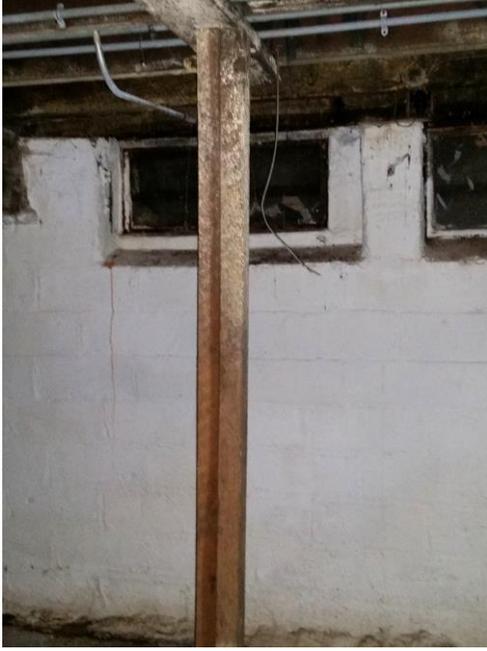
| OBSERVATIONS | REFERENCE PHOTO |
|---|--|
| <p>14. Individual wood posts have been added, presumably to address specific issues of deterioration or sagging floors due to heavy loads in the past.</p> | A photograph of a vertical wood post supporting a ceiling structure. The post is made of light-colored wood and is positioned in front of a white wall with a window. The ceiling above shows some sagging and structural elements. |

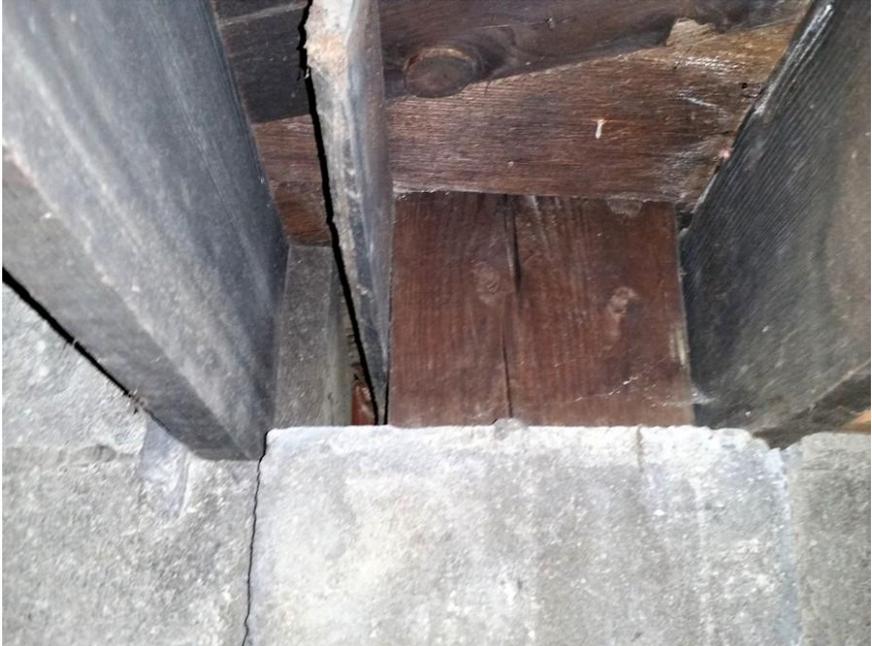
| OBSERVATIONS | REFERENCE PHOTO |
|---|--|
| <p>15. The masonry bearing walls are in overall good condition. The north wall of this space separates 4140 and 4142 Fremont, and supports the floor and wall framing for both addresses.</p> | |

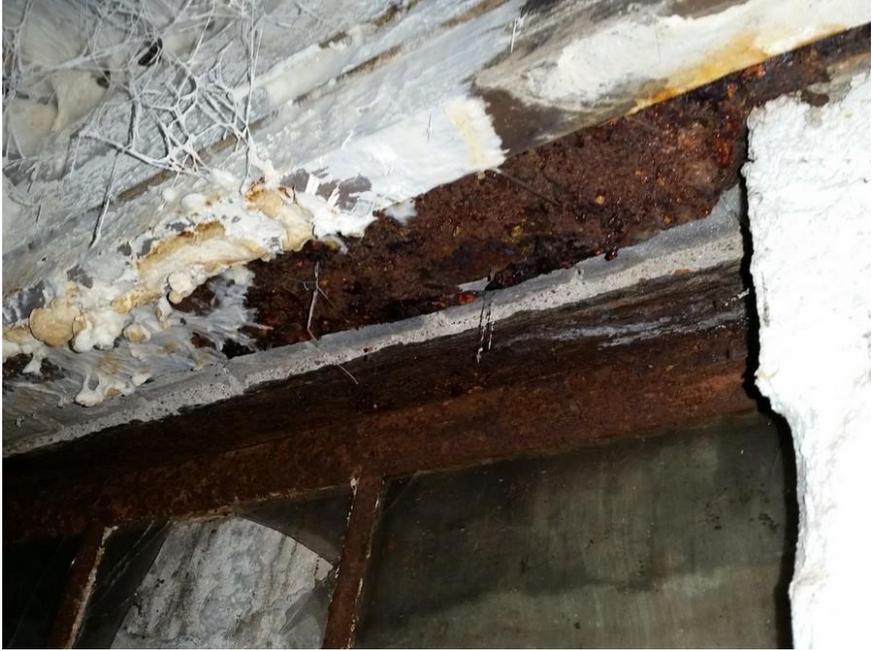
| OBSERVATIONS | REFERENCE PHOTO |
|---|--|
| <p>16. The steel lintels over window openings are heavily corroded, and are in poor condition.</p> | |

The foundations of these structures appear to be in overall good condition and performing well. Some of the window openings have been infilled with concrete masonry, while others are covered with plywood. The window openings on the east side of the building have steel

lintels supporting the brick masonry above. These steel lintels are corroding and should be replaced.

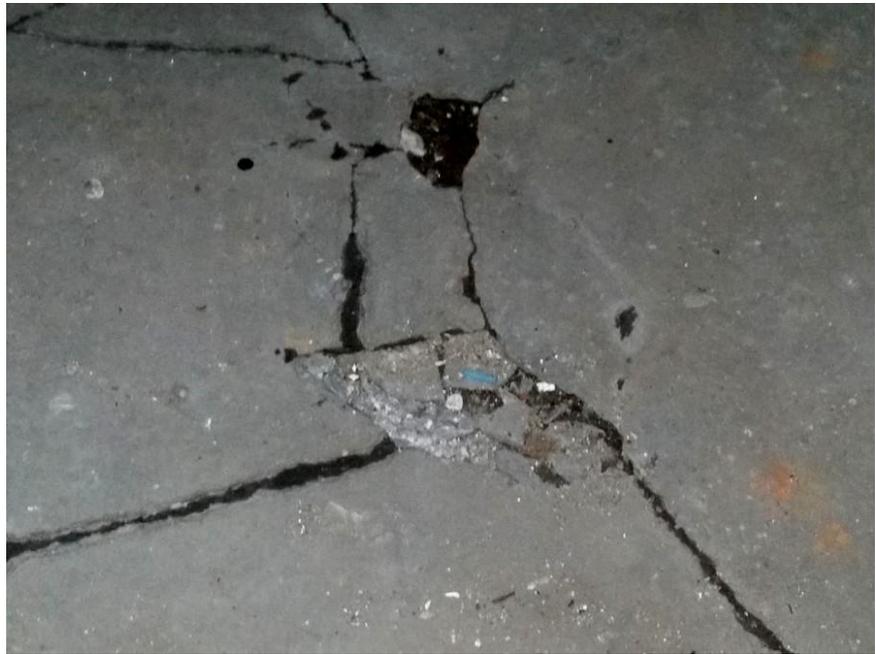
17. The concrete floor appears to be a thin slab or topping. Some areas are in poor condition, with cracking and minor heaving evident.

The concrete slab on grade is cracked and has evidence of minor heaving in all of the basements of this property. None of the conditions noted are considered a structural deficiency, but can be corrected if the basements are to be used as occupied spaces.

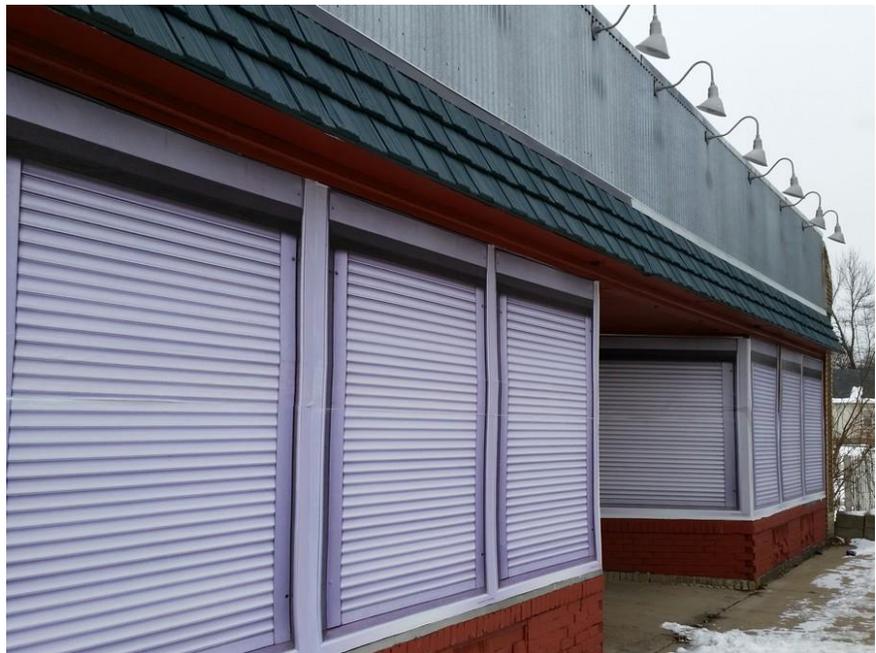
18. The building is a one story retail building with the west side fronting on Fremont Avenue. 4142 is the north portion of this building.

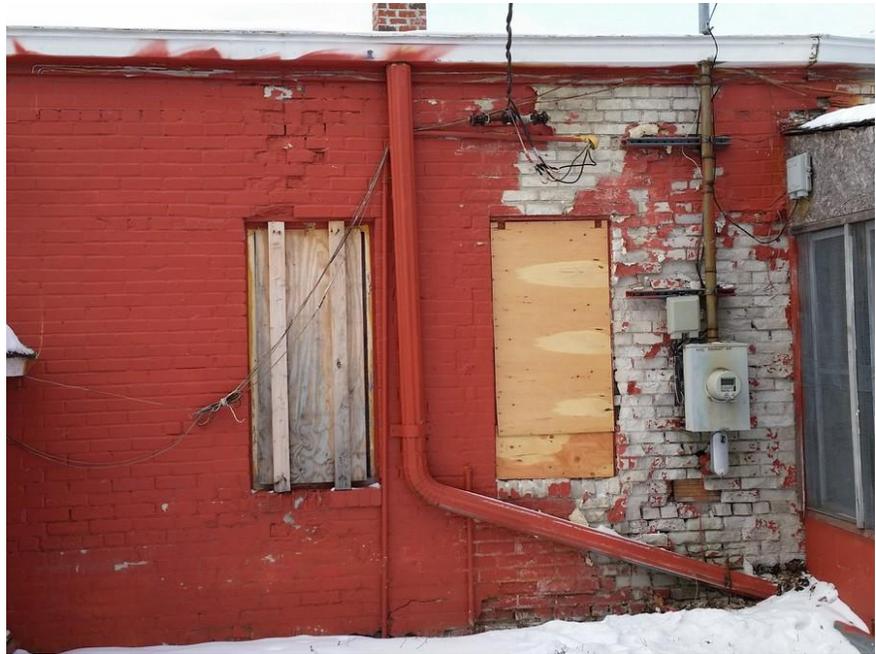
19. The east side of the building is constructed with painted brick masonry. Some deterioration of the brick masonry is evident, likely due to moisture being trapped in the masonry by the paint.

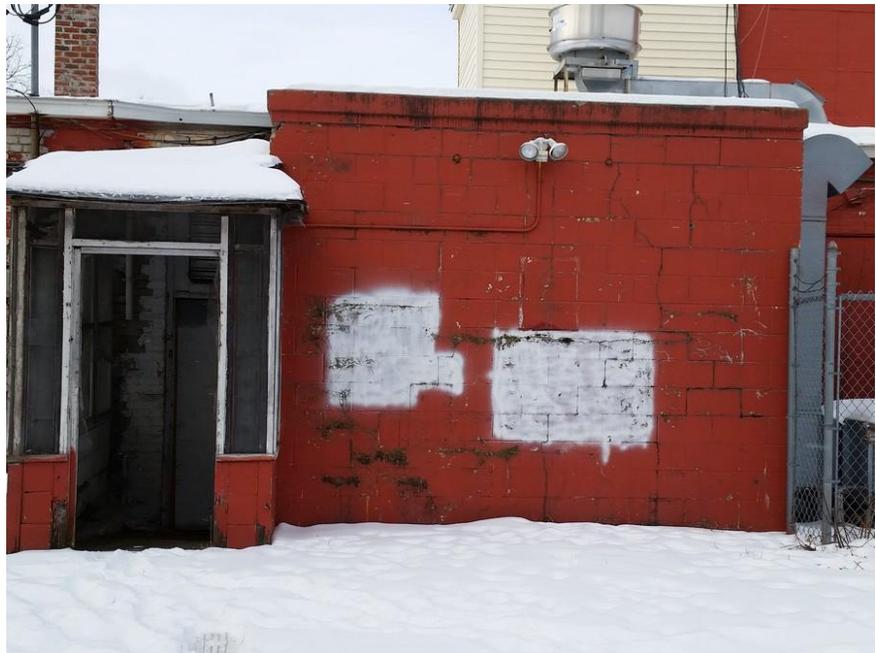
20. A concrete block addition was also constructed on the east side. Some deterioration of the masonry is evident, including cracking and open joints.

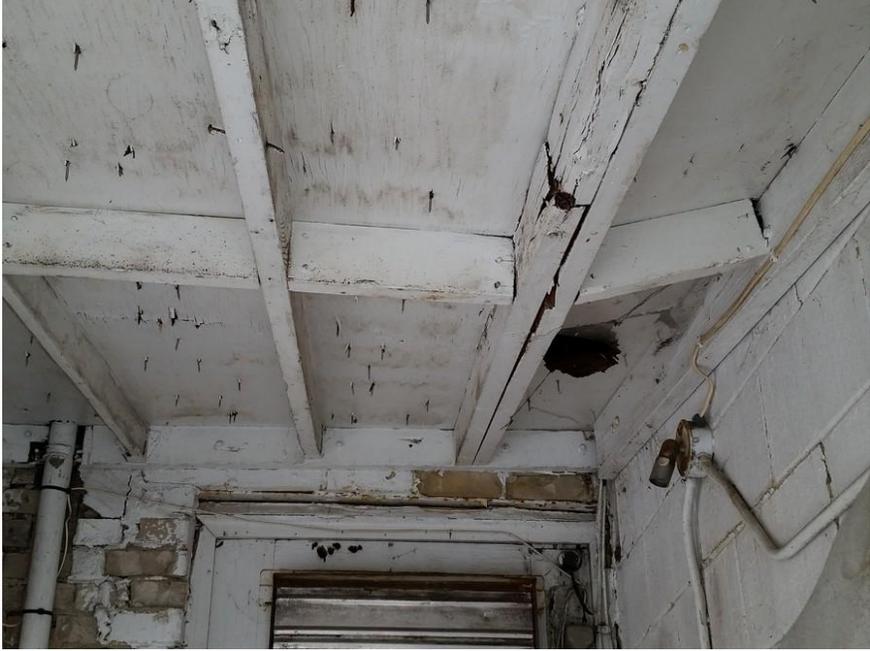
| OBSERVATIONS | REFERENCE PHOTO |
|--|--|
| 21. The wood roof framing over the rear entrance is deteriorated due to water infiltration. | A photograph showing the interior of a crawlspace or attic area. The wood framing, including joists and rafters, is heavily deteriorated, with significant rot and missing sections. A dark, irregular hole is visible in the wood above a doorway. The walls are made of concrete blocks, and there are some pipes and electrical conduits visible. |

- Deteriorated roof framing over rear entrance: Remove and replace the wood framing to match existing.

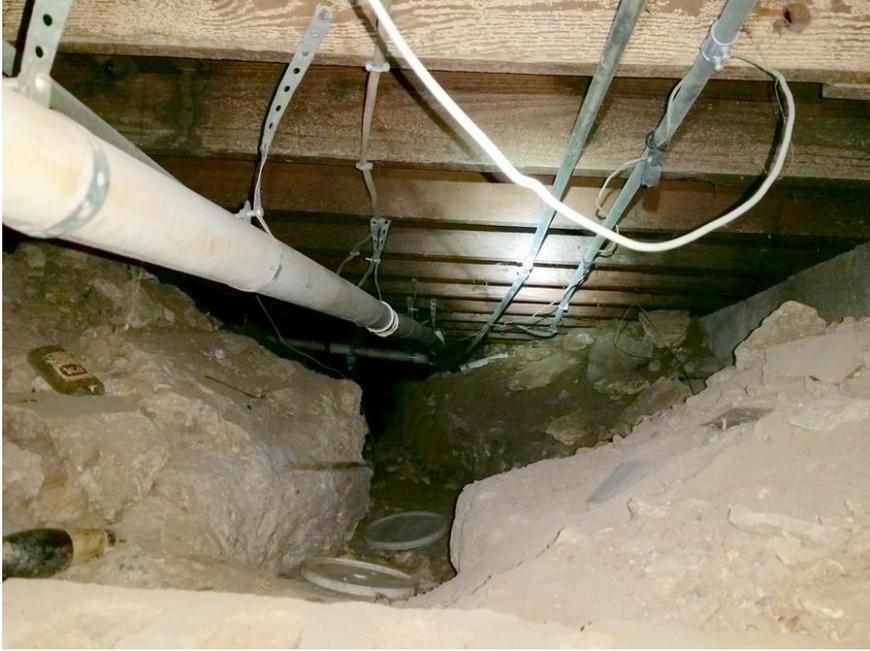
| OBSERVATIONS | REFERENCE PHOTO |
|--|--|
| 22. A crawlspace is located under the west half of the first floor. The floor is framed with wood joists, supported by masonry walls. The framing was mostly inaccessible for inspection, but appears to be in overall good condition. | A photograph of a crawlspace. The floor is supported by wooden joists. The walls are made of masonry blocks. There are several pipes and electrical conduits running through the space. The area appears to be well-maintained and in good condition. |

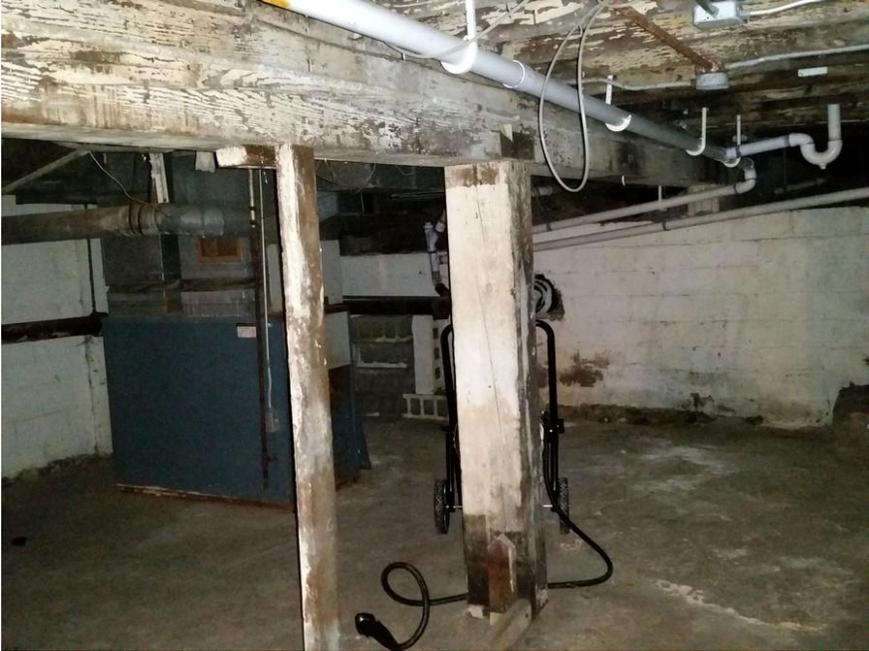
| OBSERVATIONS | REFERENCE PHOTO |
|--|--|
| <p>23. A basement is located under the east half of the first floor. The floor is framed with wood plank sheathing supported by wood joists, beams, and columns. All framing appears to be in overall good condition, with some localized deterioration.</p> | |

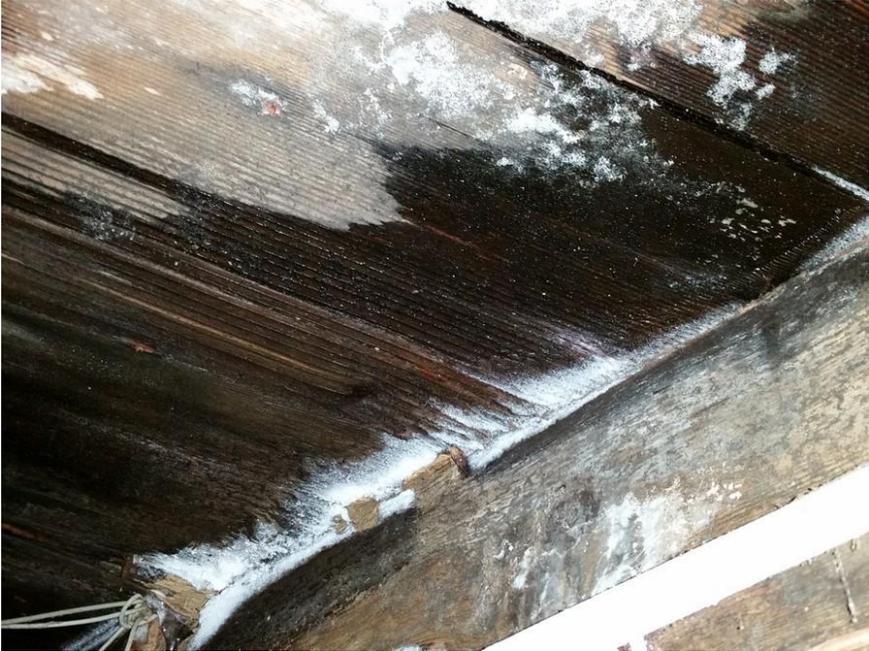
| OBSERVATIONS | REFERENCE PHOTO |
|--|--|
| <p>24. The floor sheathing of the first floor is wet, with some deterioration on the east side of the building.</p> | |

- Deteriorated first level wood floor sheathing on the east side of the building: Remove and replace all decayed wood floor sheathing.
- Deteriorated first level floor joists on the east side of the basement. All wood joists with biological growth and decay should be removed and replaced: This will likely include the replacement of some of the wood floor sheathing as well.
- Cracked concrete masonry under beam bearing at the crawlspace: Remove and replace the one cracked concrete block beneath the beam bearing.
- Deteriorated beam bearing at east masonry wall: Install a steel angle bolted to the wall to act as a new beam bearing.

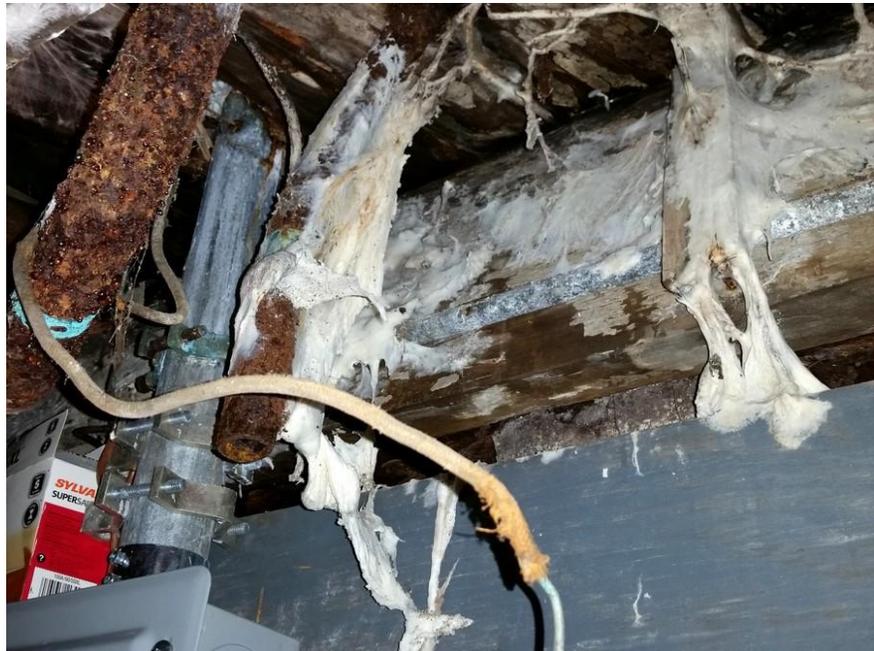
25. Heavy biological growth is evident on the floor framing on the east side of the basement.

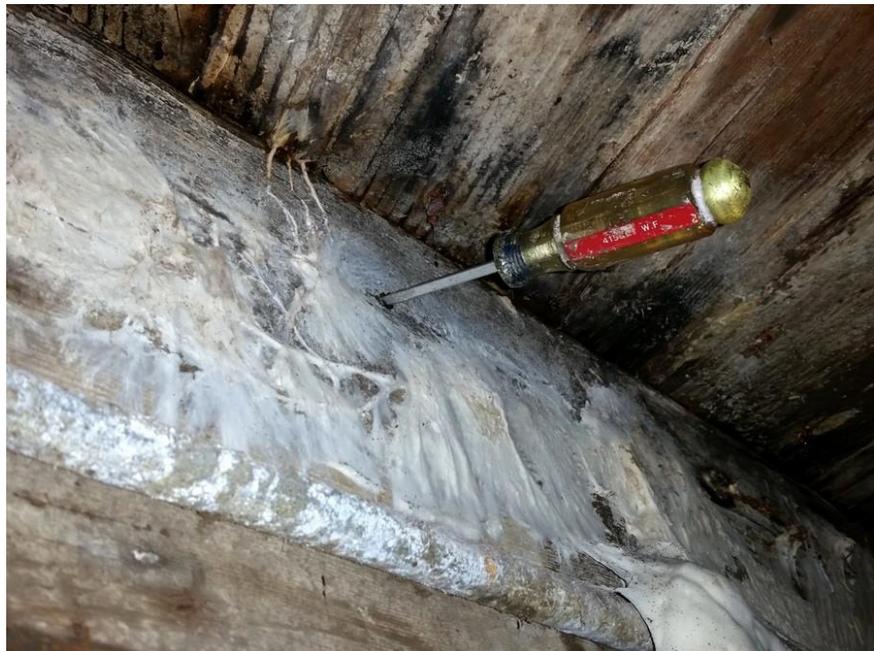
26. The first two joists on the east side of the first level are in poor condition, with significant deterioration.

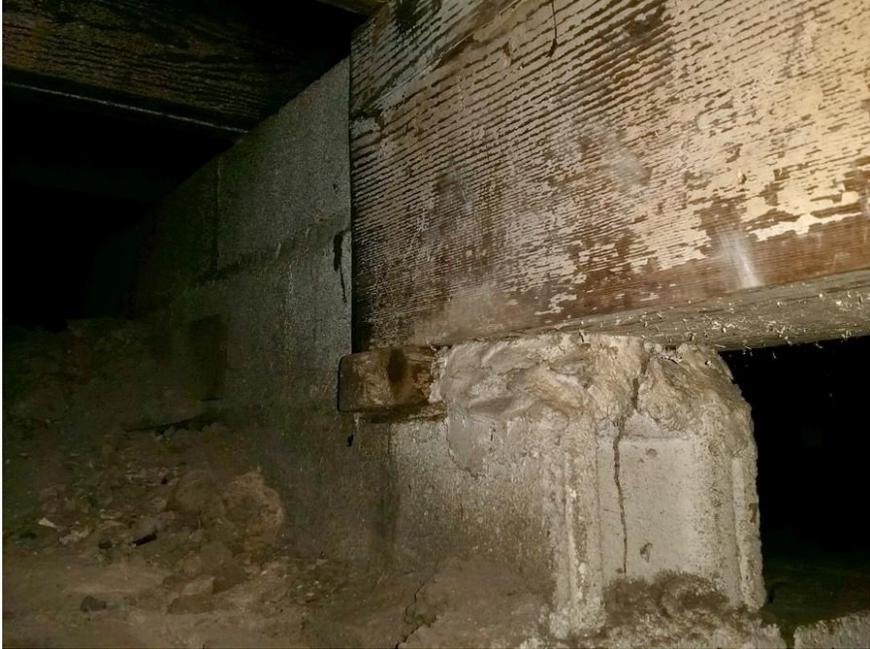
| OBSERVATIONS | REFERENCE PHOTO |
|---|--|
| <p>27. The wooden beam bears on the concrete masonry wall at the crawlspace. The block beneath the beam bearing is cracked and in poor condition.</p> | |

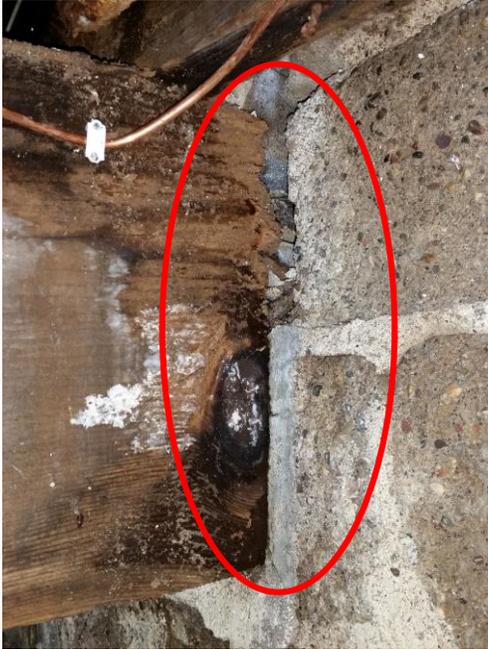
| OBSERVATIONS | REFERENCE PHOTO |
|---|--|
| <p>28. The wood beam bears on the masonry wall at the east side of the basement. The wood is deteriorated and in poor condition.</p> | |

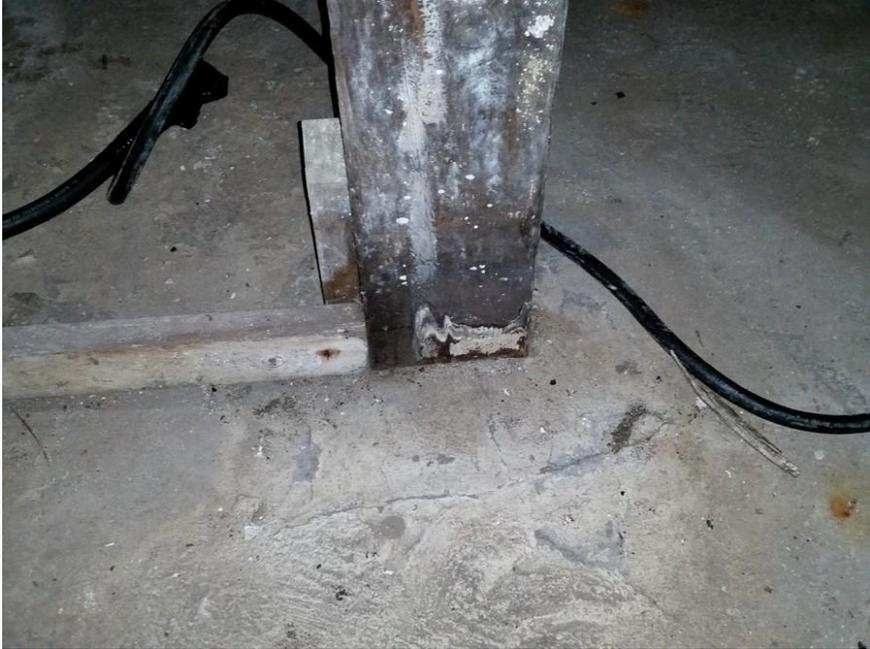
| <b>OBSERVATIONS</b> | <b>REFERENCE PHOTO</b> |
|--|---|
| <p>29. The wood columns bear directly on the concrete floor, and appear to be in overall good condition.</p> | A close-up photograph showing the base of a vertical wood column. The wood is dark, weathered, and shows signs of decay and insect damage at the point where it meets the concrete floor. A black cable runs across the floor to the right of the column. |

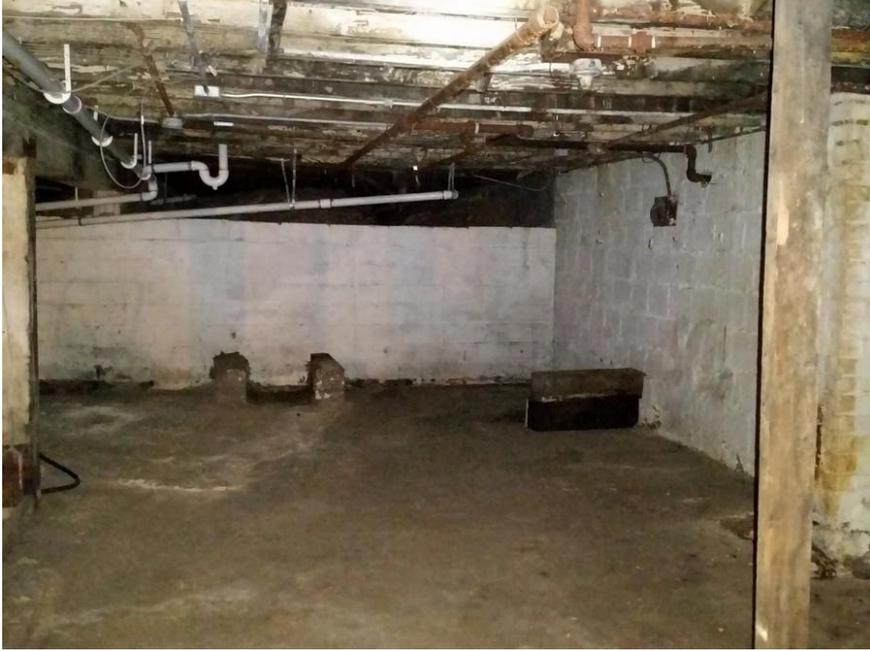
| <b>OBSERVATIONS</b> | <b>REFERENCE PHOTO</b> |
|--|---|
| <p>30. The masonry foundation walls are in overall good condition.</p> | A wide-angle photograph of a basement interior. The walls are made of light-colored masonry blocks. The ceiling is exposed, showing wooden joists, pipes, and electrical conduits. The floor is concrete. The overall condition of the masonry walls appears to be good. |

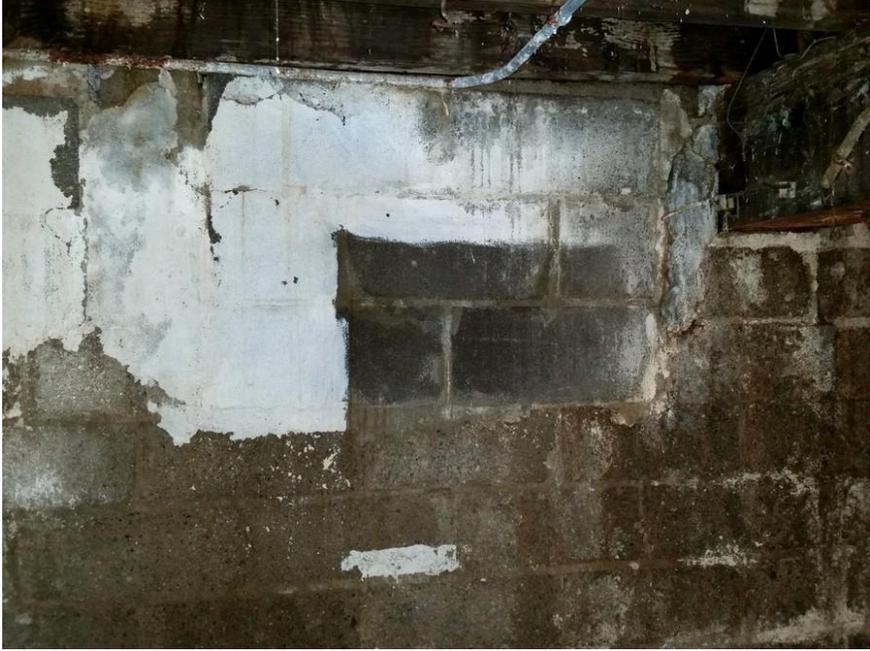
| OBSERVATIONS | REFERENCE PHOTO |
|---|--|
| <p>31. The window openings on the east side of the basement have been infilled with concrete masonry.</p> | A photograph showing a section of a basement wall. The wall is made of concrete masonry blocks. A rectangular window opening has been filled with a similar concrete masonry material. The surface of the wall is somewhat uneven and shows signs of wear or moisture. |

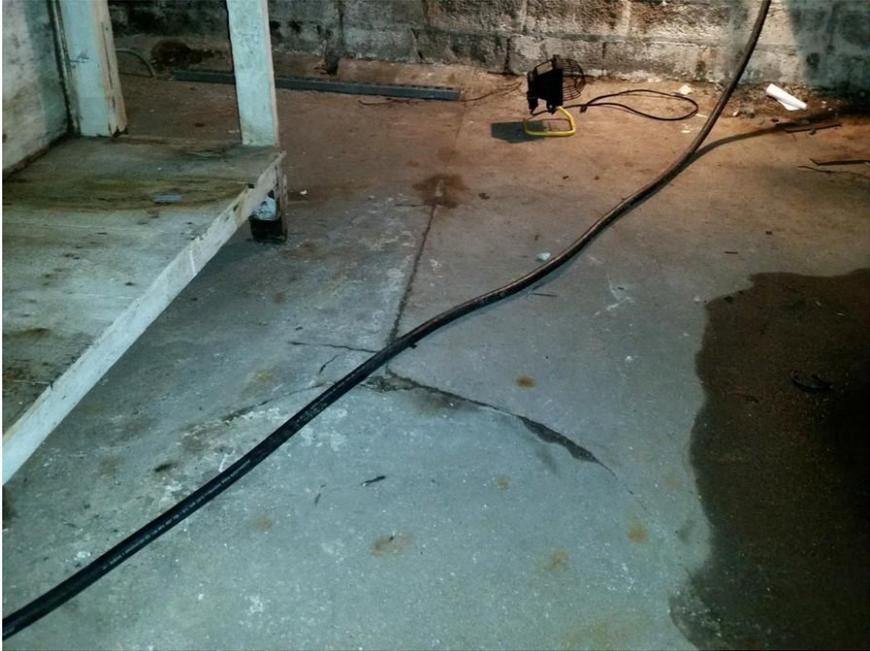
| OBSERVATIONS | REFERENCE PHOTO |
|---|--|
| <p>32. The concrete floor is in overall good condition, with some minor cracking and heaving.</p> | A photograph of a concrete floor in a basement. The floor is light-colored and shows some minor cracking and discoloration. A black cable runs across the floor from the foreground towards the background. In the background, there is a concrete wall and some equipment or debris. |

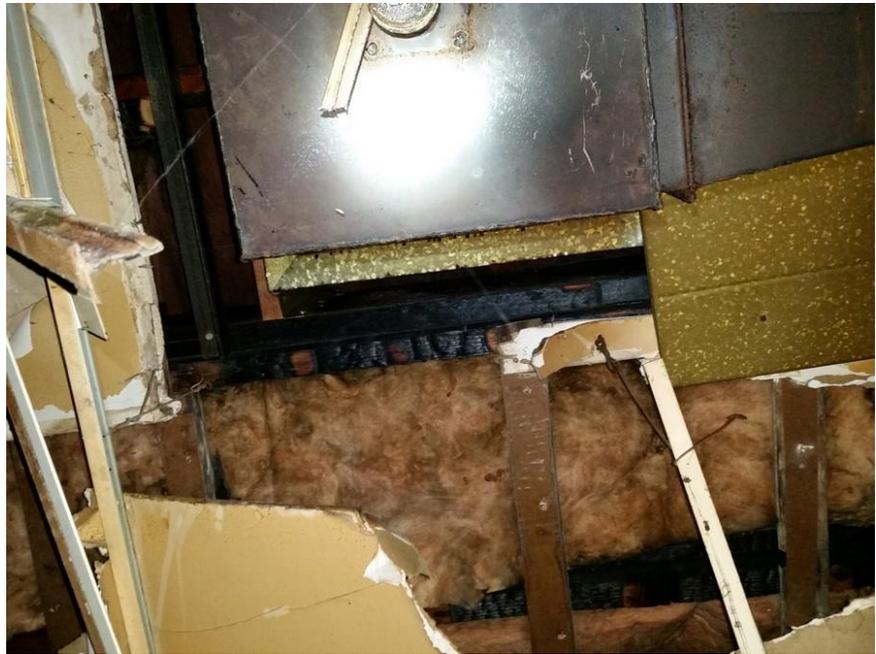
33. A portion of the roof framing was visible. It is apparent that the framing is charred from a previous fire.

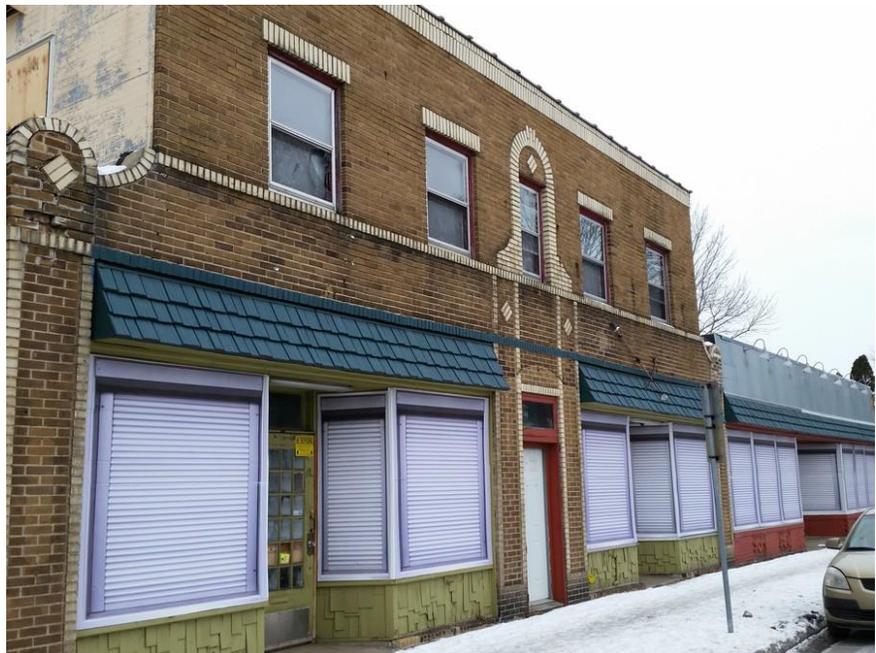
34. The building is a two story mixed-use retail and apartment building, with the west side fronting on Fremont Avenue.

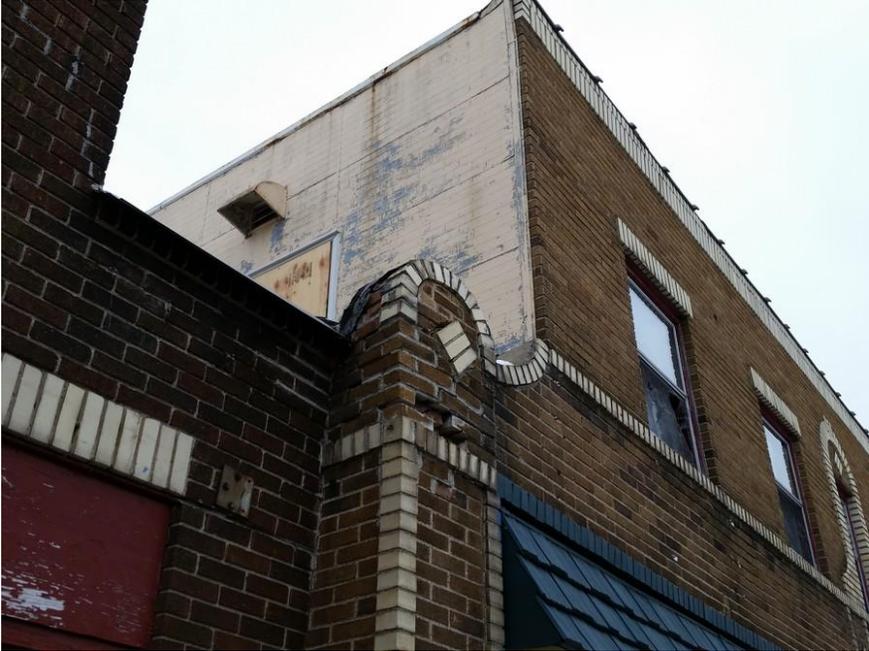
| OBSERVATIONS | REFERENCE PHOTO |
|---|--|
| <p>35. The north side of the exterior wall is covered with metal siding. Due to the inset configuration of the upper level, the wall is likely not masonry construction.</p> | |
