# 4140 – 4146 Fremont Avenue North Minneapolis, MN

## Structural Condition Assessment

February 6, 2016

Re: 4140 – 4146 Fremont Avenue North - Structural Condition Assessment  
CDG Project 16010.00

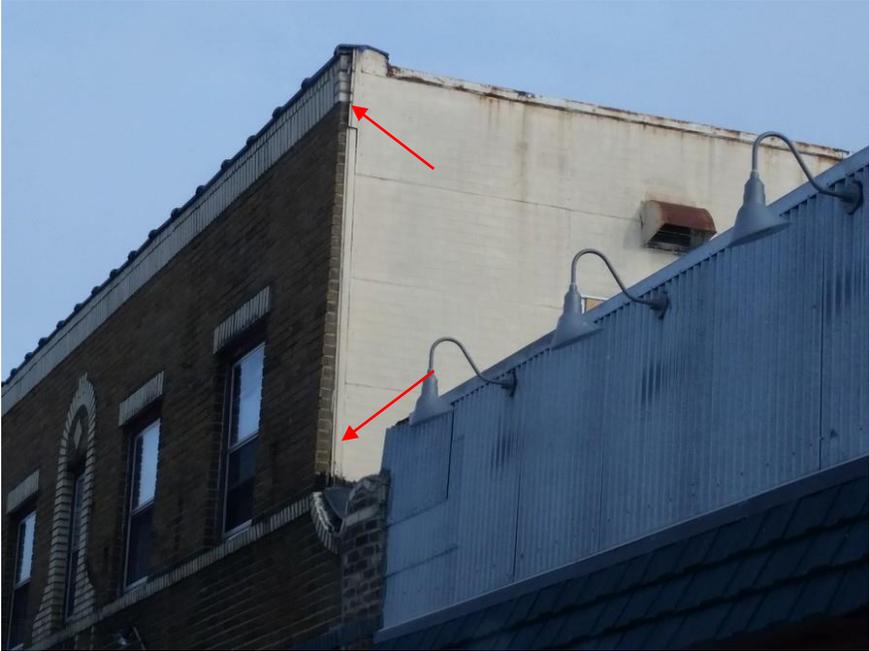
| OBSERVATIONS | REFERENCE PHOTO |
|---|--|
| <p>36. The south side of the exterior wall is covered with metal siding. Due to the inset configuration of the upper level, the wall is likely not masonry construction.</p> <p>Some movement of the brick veneer on the west elevation may be occurring at isolated locations.</p> | |

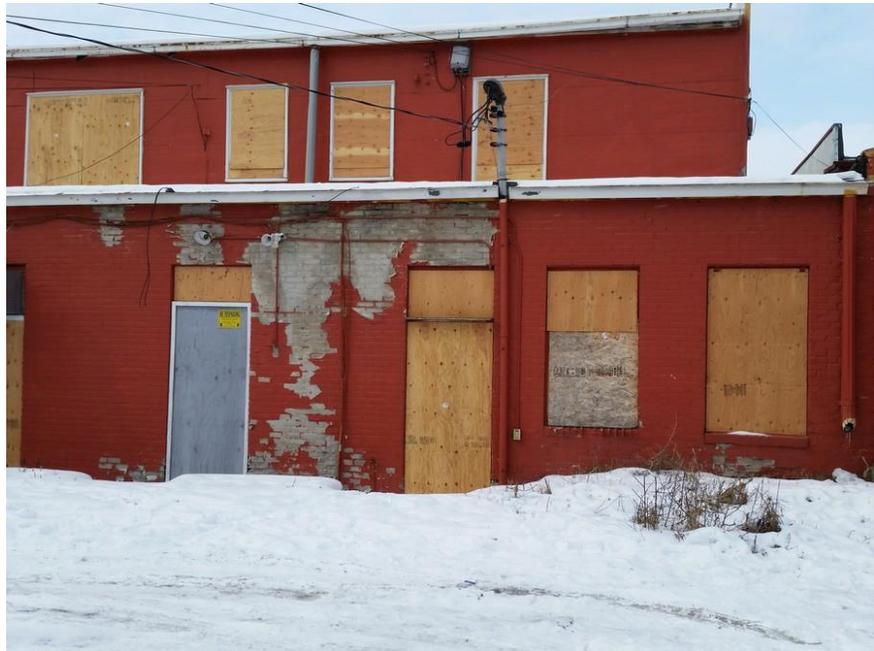
37. The lower level of the east side of the building is constructed with painted brick masonry. Some deterioration of the brick masonry is evident, likely due to moisture being trapped in the masonry by the paint.

The upper level walls are covered with metal sheet siding, and are likely not masonry.

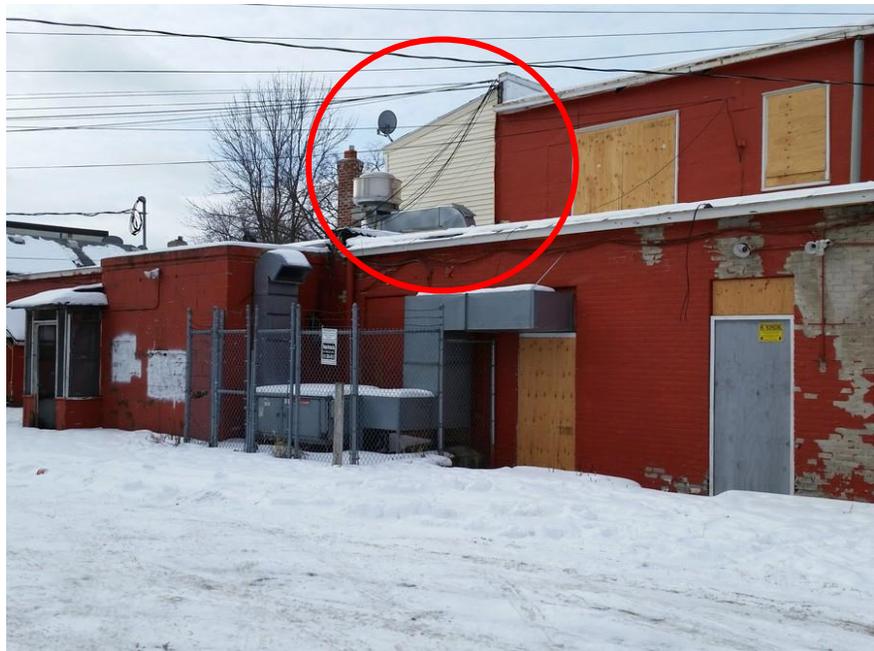
38. A wood framed addition was constructed on the south side of the roof. The addition appears to be partially constructed on the roof of 4142 Fremont, but the space is accessed through the upper level of 4146 Fremont.

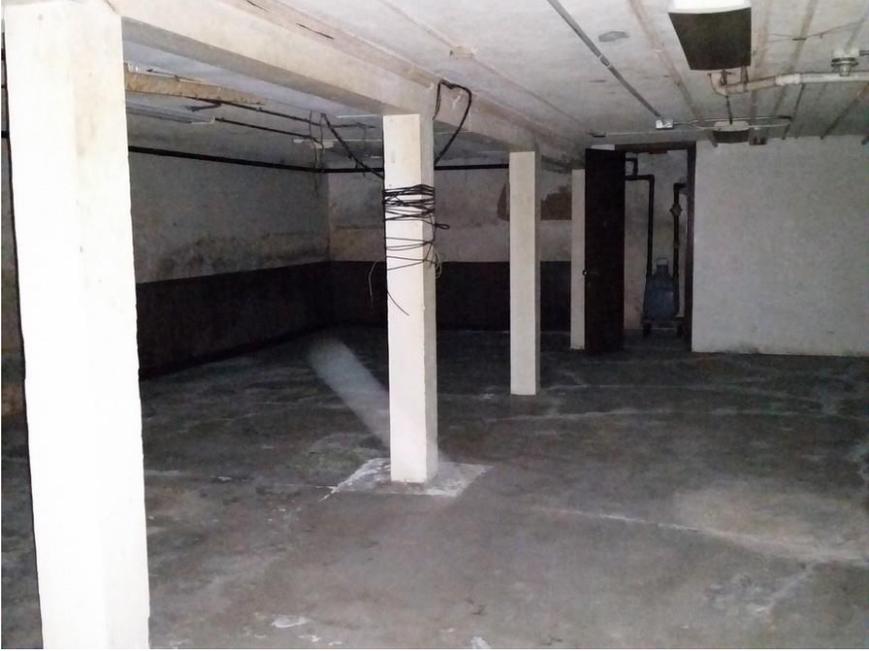
| OBSERVATIONS | REFERENCE PHOTO |
|---|--|
| <p>39. A basement is located under the entire building. The first floor is framed with wood plank sheathing supported by wood joists, beams, and columns. All visible framing appears to be in overall good condition, with some localized deterioration.</p> <p>This photo is of the south half of the basement.</p> | A photograph of a basement interior showing several vertical concrete columns supporting a ceiling with exposed pipes and ductwork. The floor is concrete and appears somewhat worn. |

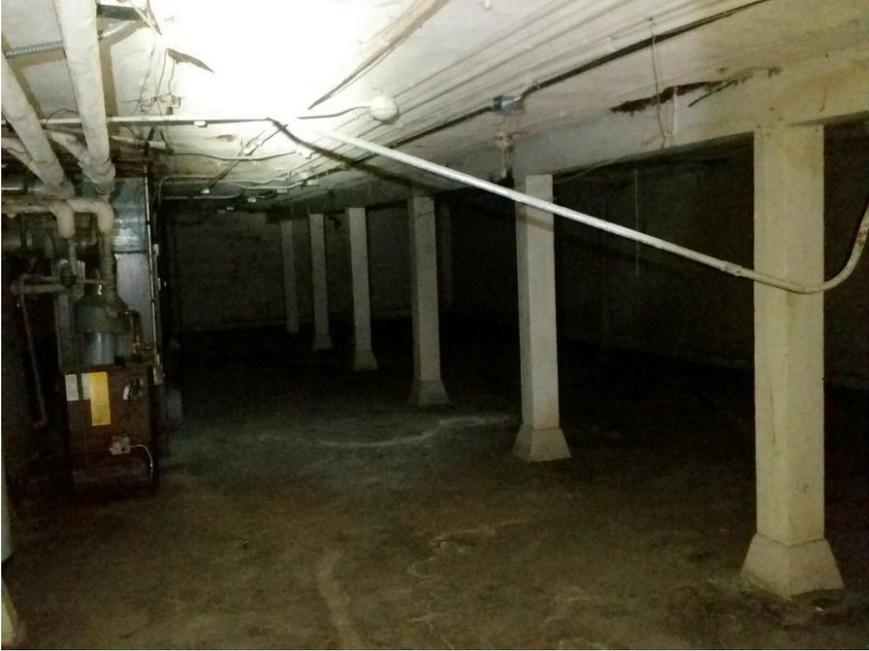
| OBSERVATIONS | REFERENCE PHOTO |
|---|--|
| <p>40. A basement is located under the entire building. The first floor is framed with wood plank sheathing supported by wood joists, beams, and columns. All visible framing appears to be in overall good condition, with some localized deterioration.</p> <p>This photo is of the north half of the basement.</p> | A photograph of a basement interior showing a row of vertical concrete columns. The ceiling has exposed pipes and ductwork. The floor is concrete. |

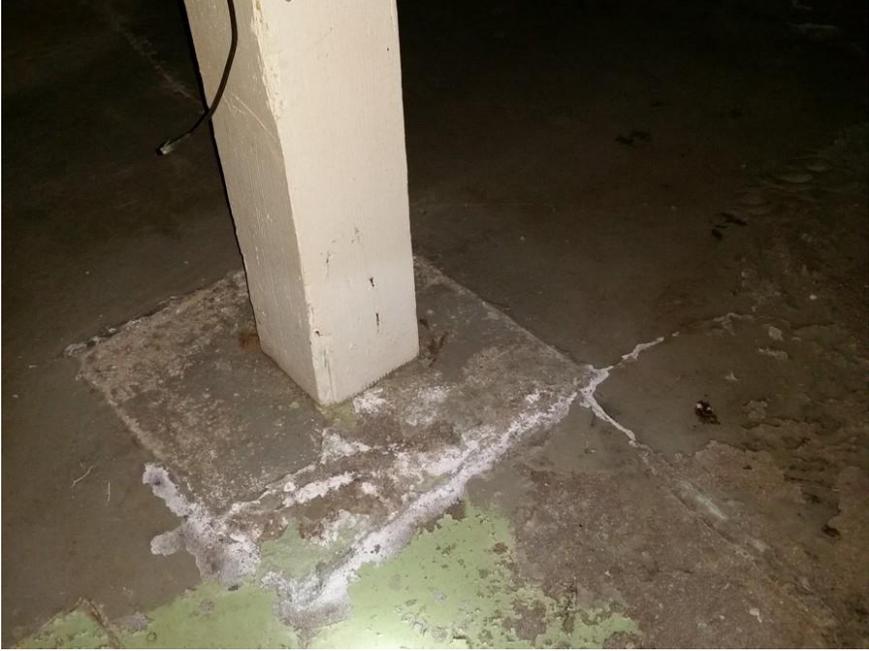
| OBSERVATIONS | REFERENCE PHOTO |
|---|--|
| 41. The wood columns bear directly on concrete foundations on the south half of the basement. | A photograph showing a vertical wood column resting on a square concrete foundation. The wood is light-colored and shows some wear. The concrete is dark and has some white residue or mold on its surface. The background is dark, suggesting an indoor basement setting. |

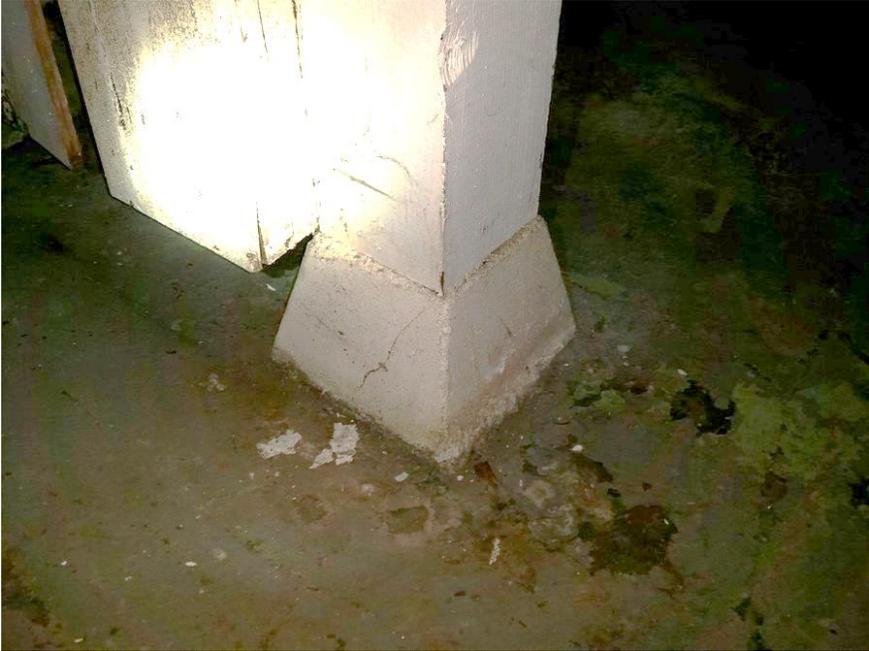
| OBSERVATIONS | REFERENCE PHOTO |
|---|--|
| 42. The wood columns bear on raised concrete blocks on the north half of the basement. | A photograph showing a wood column resting on a raised concrete block. The wood is light-colored and shows some wear. The concrete block is light-colored and has some white residue or mold on its surface. The background is dark, suggesting an indoor basement setting. |

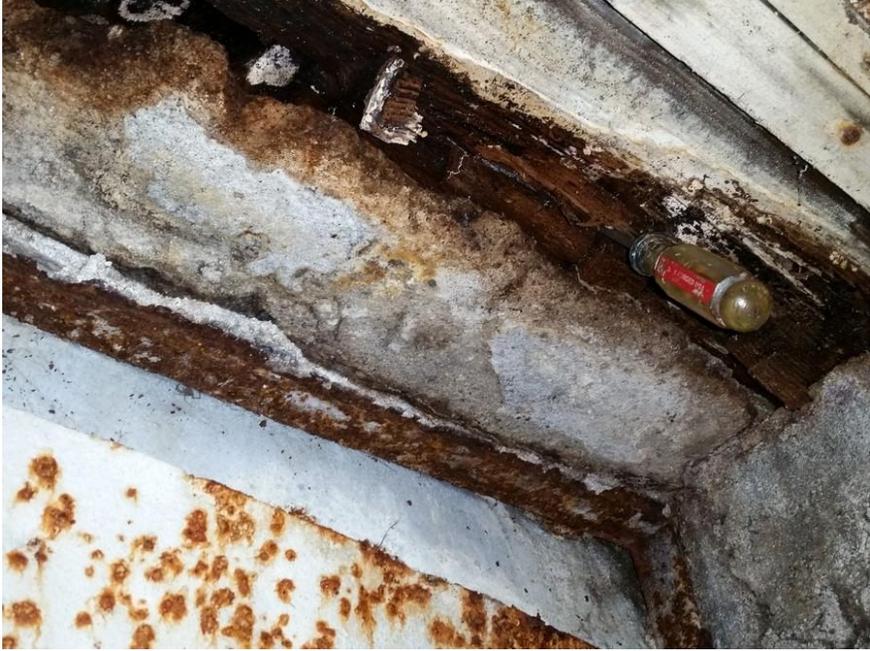
| OBSERVATIONS | REFERENCE PHOTO |
|--|---|
| 43. Some wood joists are deteriorated in isolated locations. | A close-up photograph showing a wooden joist that has been severely deteriorated by rot. The wood is dark, charred, and crumbling. A screwdriver is placed horizontally against the joist to provide a sense of scale. The surrounding area shows signs of moisture damage and mold on the concrete or masonry surfaces. |

- Deteriorated first level floor joists: Install new floor joists for the entire length of the joist adjacent to any deteriorated joist.

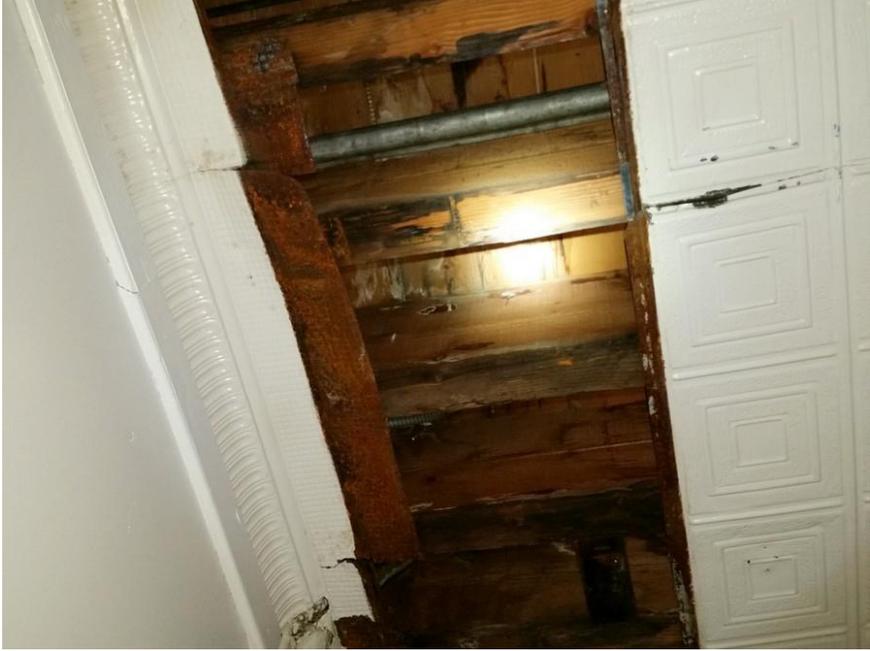
| OBSERVATIONS | REFERENCE PHOTO |
|--|---|
| 44. The second level floor framing uses heavy timber joist framing, likely to support the second level walls that are inset, not aligning with the foundation walls on the north and south sides (see Photos 35 & 36). | A photograph of a crawlspace showing heavy timber joist framing. The joists are large, dark, and appear to be made of solid wood. They are supported by a metal pipe. The space is dimly lit, with a light source visible in the background. White baseboards and a white door are visible on the right side of the frame. |

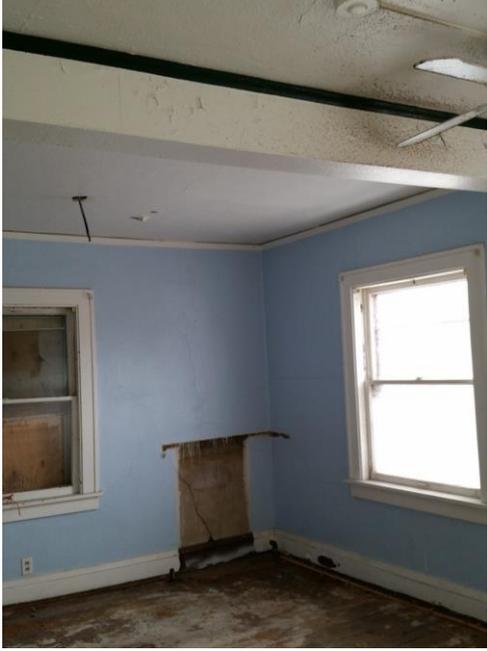
| OBSERVATIONS | REFERENCE PHOTO |
|---|--|
| 45. The second level is completely finished with plaster walls and ceilings. Some minor cracks are evident. | A photograph of an interior room with light blue walls and a white ceiling. The ceiling shows signs of damage, including a large hole and exposed wooden joists. There are two windows with white frames. The floor is dark and appears to be in poor condition. |
