BOULEVARD TREE FAILURES
DURING WIND-LOADING EVENTS:
JUNE 21, 2013...A CASE STUDY

A REPORT TO THE MINNEAPOLIS CITY
COUNCIL FEBRUARY 3, 2015

UNIVERSITY OF MINNESOTA
DEPARTMENT OF FOREST
RESOURCES

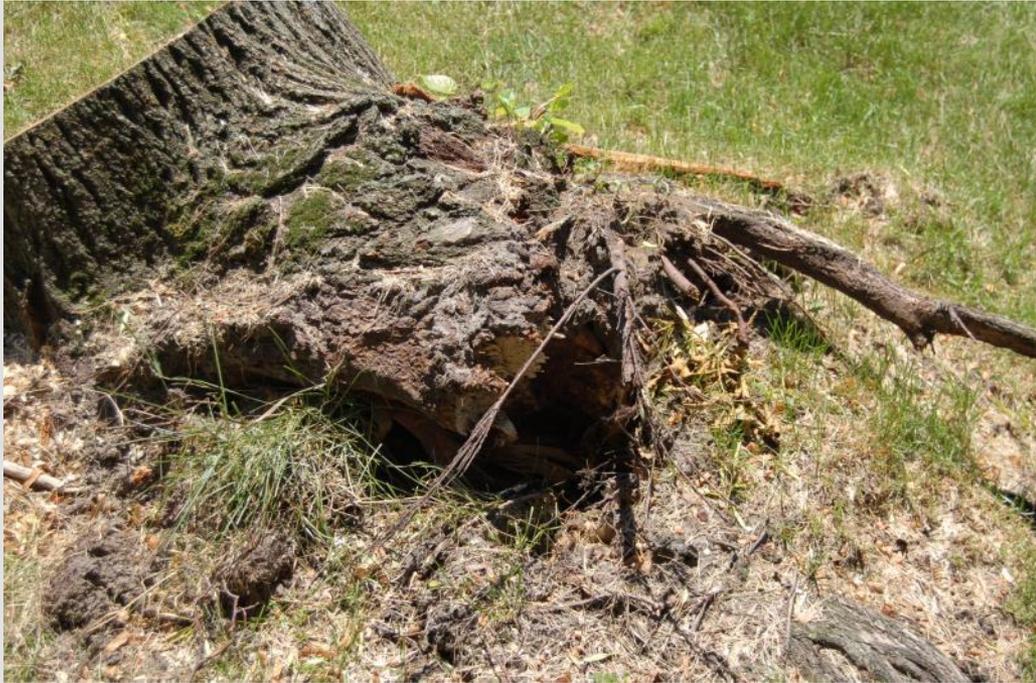
Greater Than 50%

TIPS/PARTIAL TIPS

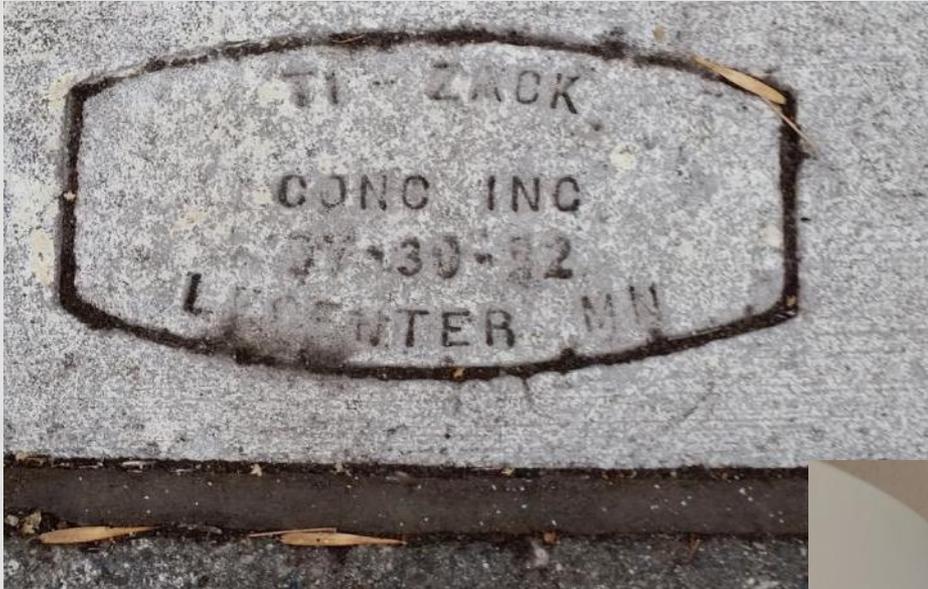
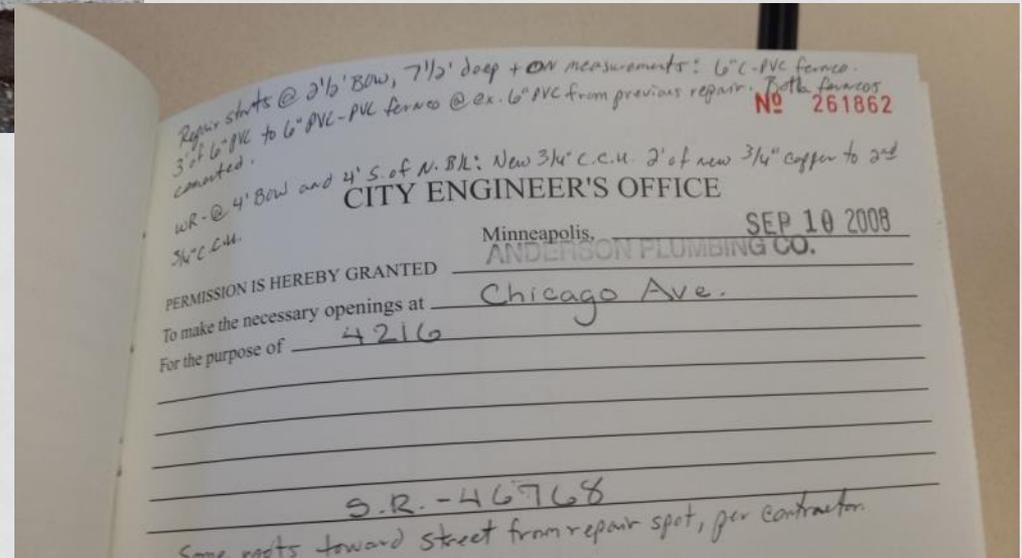
SIDEWALK OR CURB REPLACEMENT

- The major finding is that **having replacement work done increased the odds of root failure by 2.24 times** (95% CI: 1.77, 2.83; $p < 0.0001$).
- For illustration, when no replacement work was done, the average Tilia had a 10.6% chance of root failure; this increased to 21.0% when replacement work was done.
