***Combined Sewer Bypasses and Overflows: Annual Report - 2014***  
Subject: Metropolitan Council/City of Minneapolis Combined Sewer Overflow (CSO)  
NPDES/SDS Permit No. MN0046744

**2014 Annual Report**  
**Combined Sewer System in Minneapolis and St Paul**  
April, 2015

**ANNUAL REPORT ON 2015 MINNEAPOLIS COMBINED SEWER  
OVERFLOW PROGRAM & 2014 ACTIVITIES**

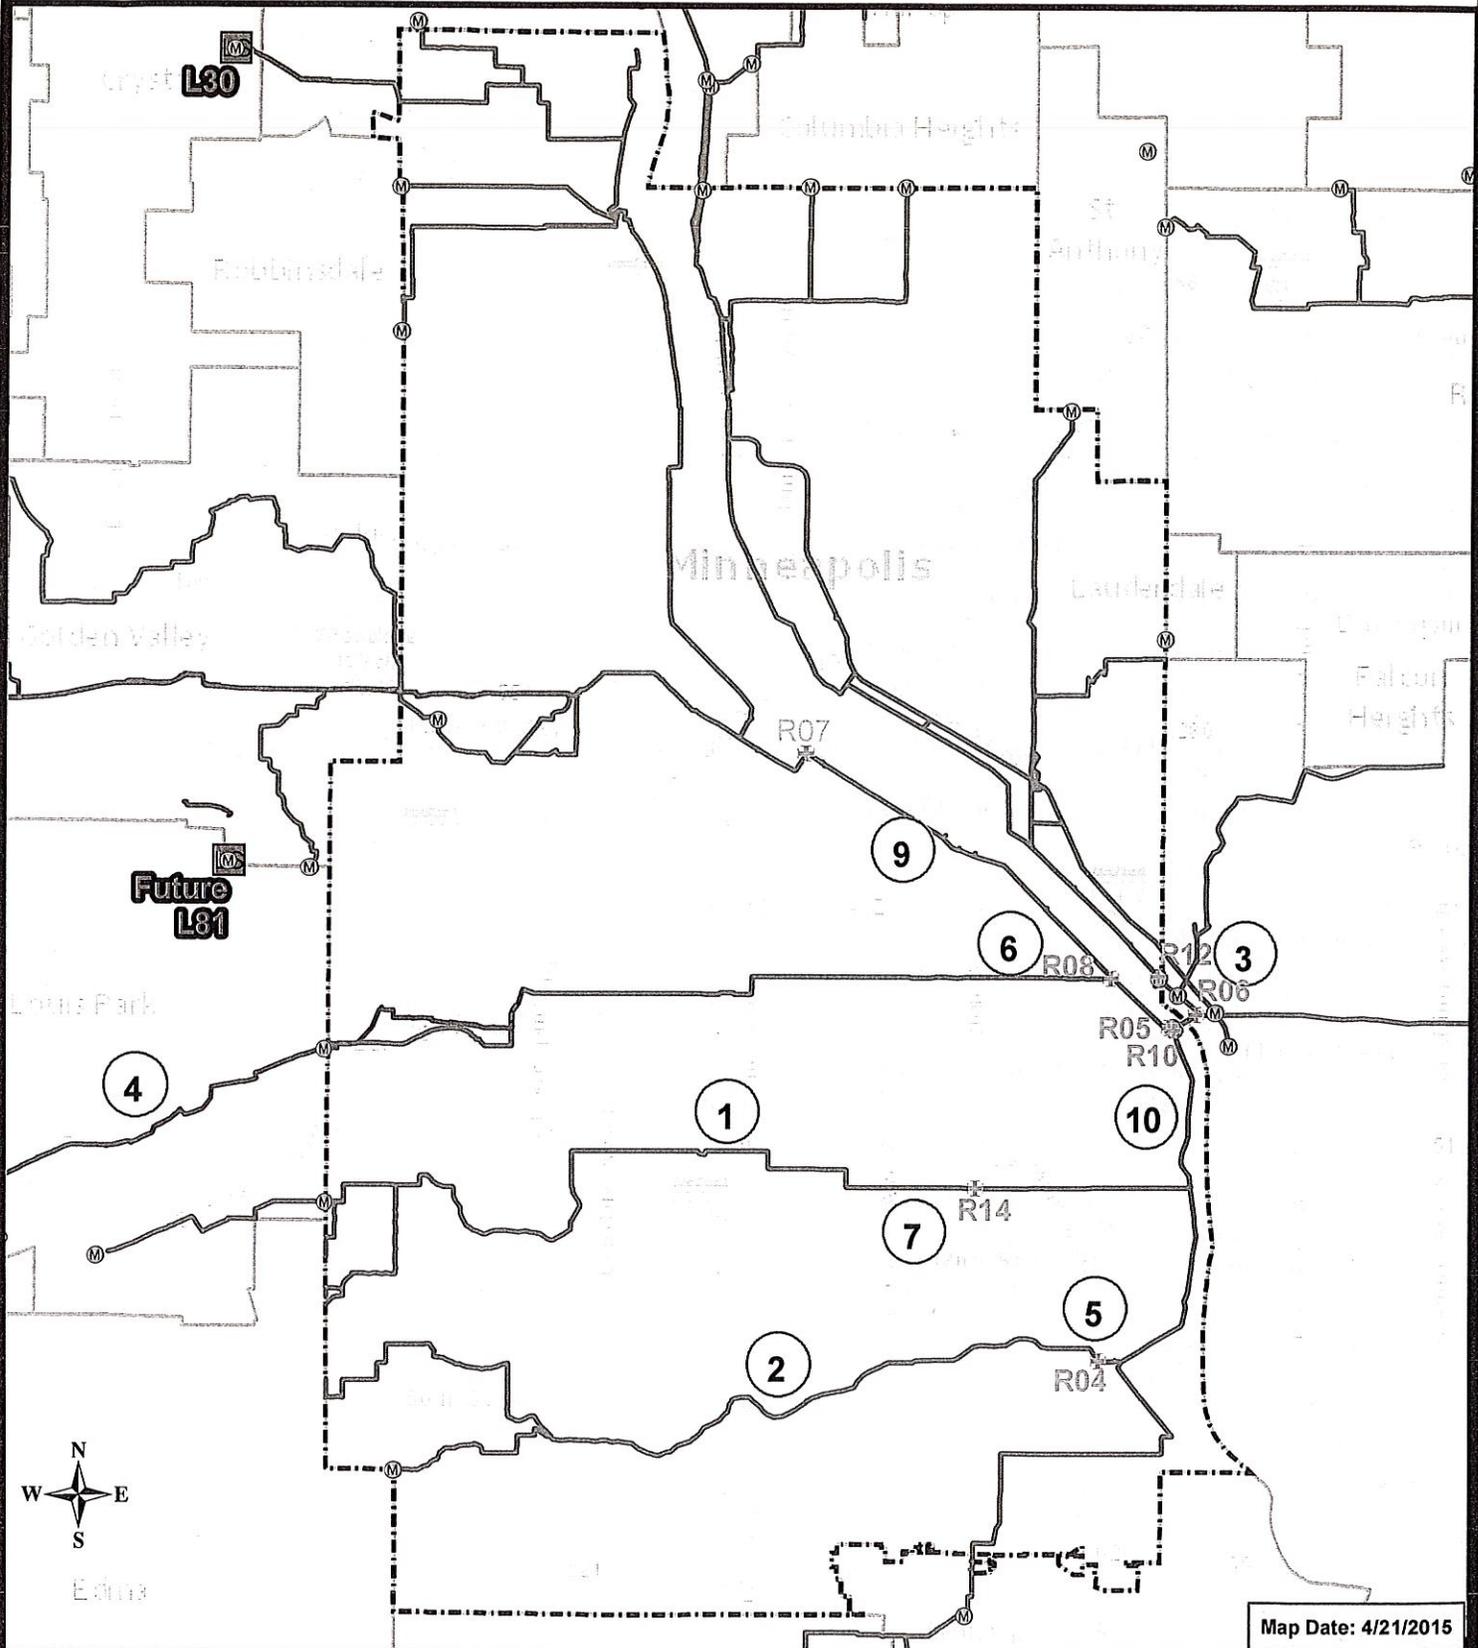
# Minneapolis Capital Projects

- Interceptor Facilities
- Gravity Interceptors
- Forcemains
- LS Lift Stations
- M Meters
- ✦ Regulators
- Minneapolis City Boundary
- Community Boundaries

No.	Project Description	Construction Schedule
1	Rehabilitation (CIPP lining) of I-MN-341 (through Lyndale Park)	2014 - 2015
2	Rehabilitation (CIPP lining) of I-MN-344	2014 - 2015
3	Regulator Improvements (R06, R10 & R12); Odor Control; SCADA Improvements	2015 - 2016
4	Hopkins Forcemain Replacement (East Isles)	2016-2018
5	Replacement of I-MN-344 Tunnel and R04; Odor Control	2016 - 2017
6	Replacement or Elimination of R08; Odor Control	2016 - 2017
7	Replacement or Elimination of R14	TBD
8	Rehabilitation of Maintenance Access Structures (those not included in foregoing projects)	2017 - 2019
9	I-MN-310/320 Diversion Sewer to MEI (undergoing a study)	TBD
10	Parallel Conveyance Sewer for I-MN-340 (to start undergoing a study)	TBD

A number of capital improvements and studies were completed during 2014 or are currently underway to reduce CSO overflows, as described in this section and the following 'Mainneapolis Capital Projects' map and project listing.

- (1) Construction was completed on the R20 Regulator and R05 Regulator in 2014, effectively closing them.
- (2) Construction was completed on the 3rd and Commercial (R02) regulator in 2013. The work of this project consists of installing new sluice gates, electrical equipment, a standby generator and restoration of concrete surfaces. The R02 overflow weir was closed in 2014. Improvements, similar to the R02 2013 work, are now in construction for regulators R06, R10 and R12. Design is nearing completion for R04 regulator improvements. This work and upcoming regulator work includes improvements to allow facilities to function effectively as CSO regulators in the near term and as emergency bypass locations in the long term.

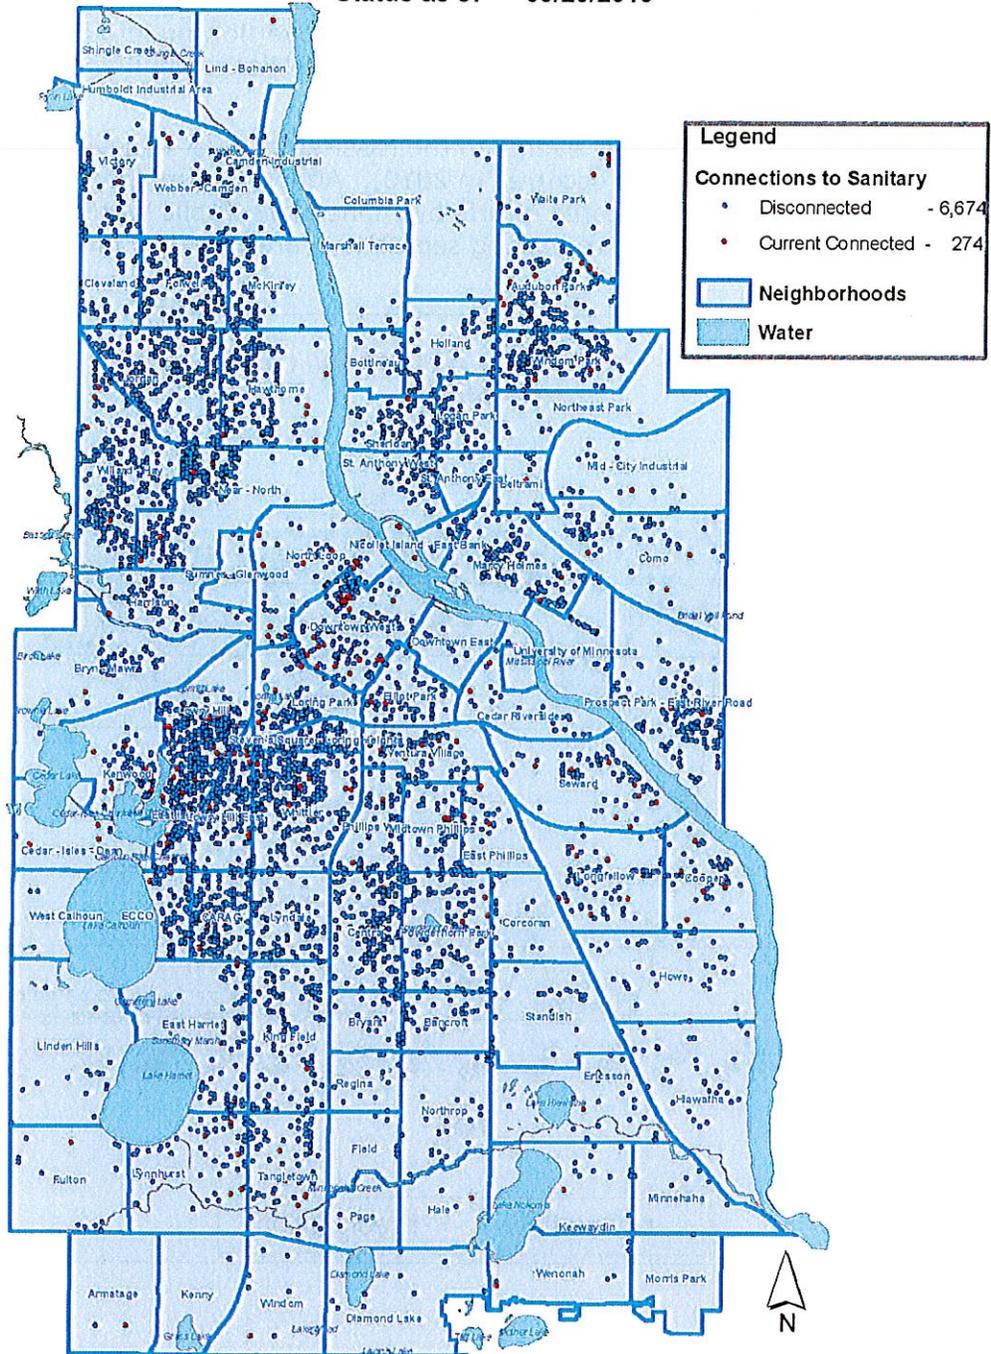
Figure 2

**City of Minneapolis - Rainleader Disconnect Program  
Status as of - 03/20/2015**

The City of Minneapolis system is a combined system due to the known inflow at catch basin and roof leader connections, and unknown sources of Inflow and Infiltration (I & I). Progress has been made, but separation is not complete (see Figures 1 and 2).

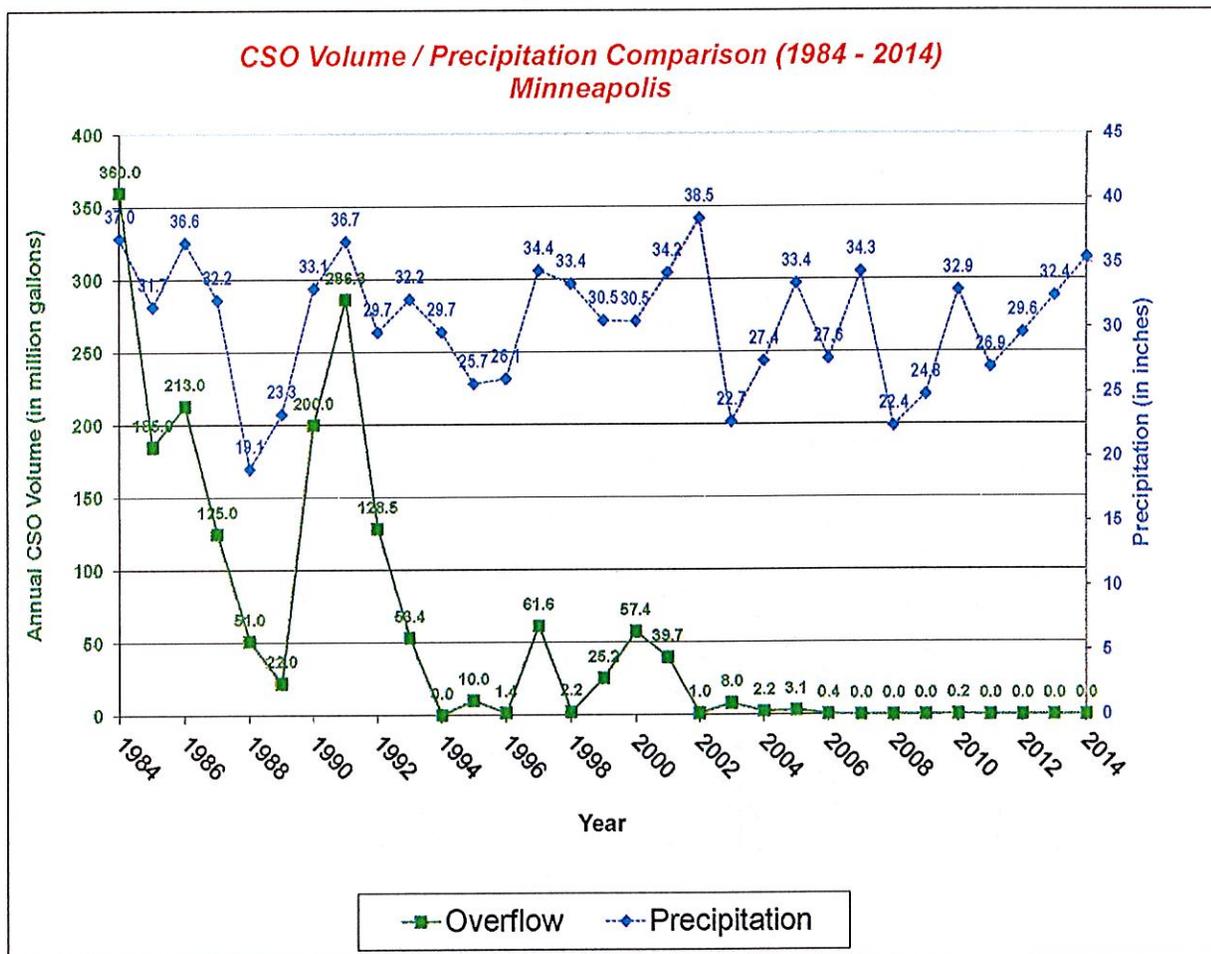
Progress has been dramatic throughout both Phase I and Phase II as upgrades to the system have been carried out (see Figure 3). Figure 3 indicates a very high percent capture since 1984. Frequency and volume of untreated sewage overflowing into the stormwater system during intense rainstorms and discharging into the Mississippi River have steadily diminished.

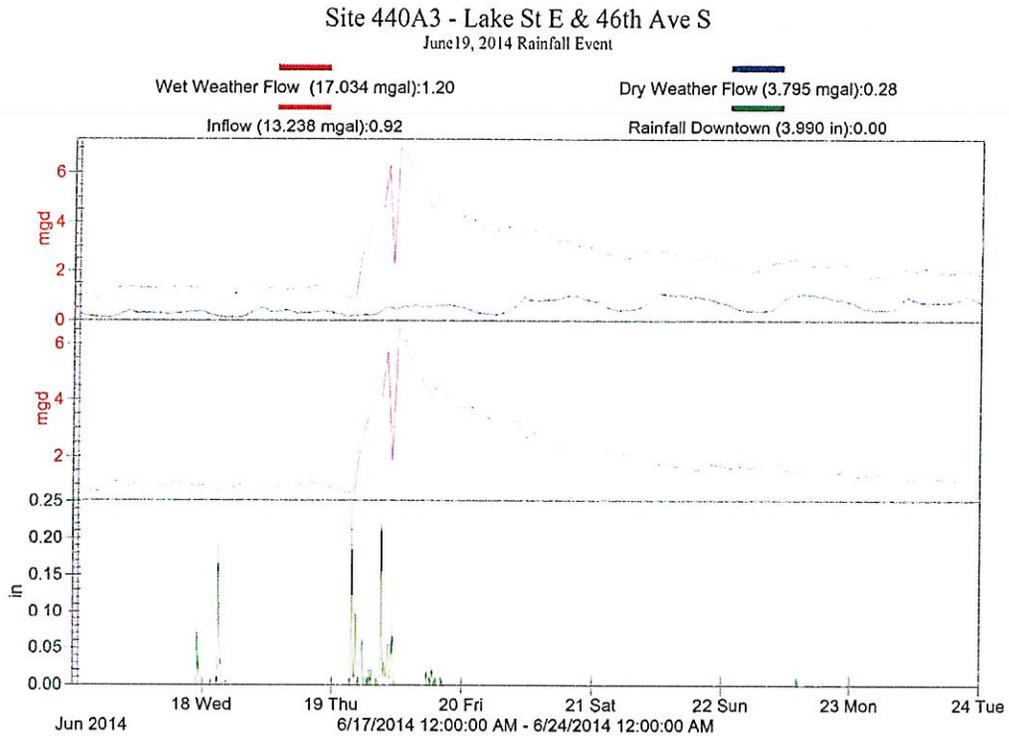
Figure 4: Meter Data

The unknown sources of inflow have an effect on the system demonstrated by the following meter data in Figure 4. This metering data reveals an immediate reaction of increased flow in the sanitary system after a rainfall event. This meter is located on the City's system in Minneapolis on Lake St E and 46<sup>th</sup> Ave S. This is representative of inflow in a sewer shed located in South Minneapolis.
